BALTIC REGION HERITAGE COMMITTEE

Good practices on built heritage conservation/restoration

Frische Grube 5, Wismar, medieval residential building.

Restoration of the half-timbered construction.

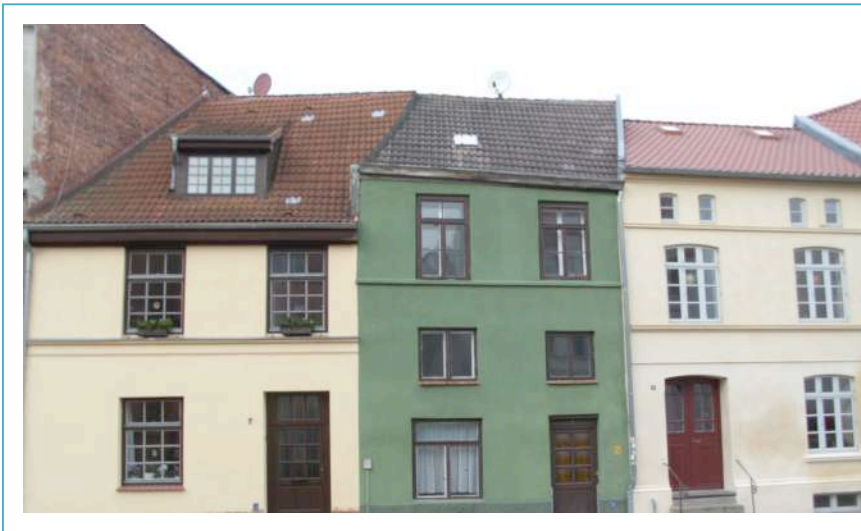
Image No. 1, Frische Grube 5 with green facade colour before restoration 2013, © LAKD M-V, LD, Jan Schirmer

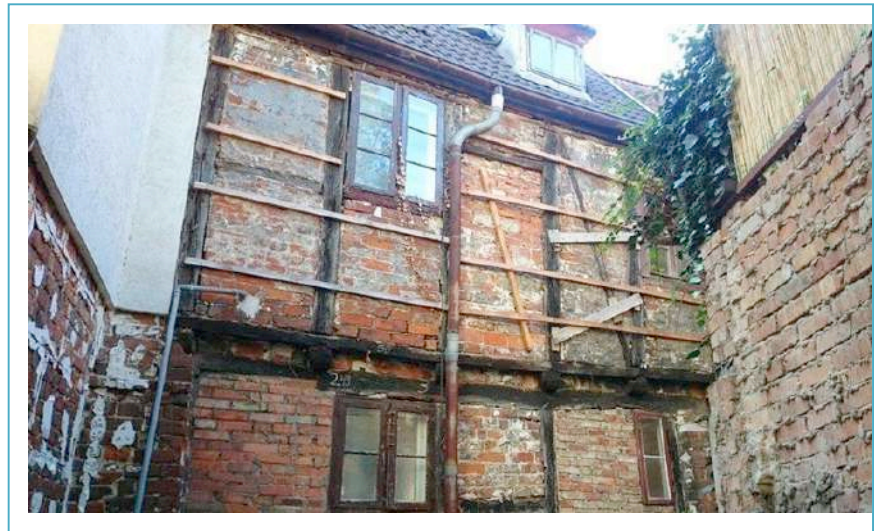
Image No. 2, Courtyard facade before restoration 2013, © LAKD M-V, LD, Jan Schirmer

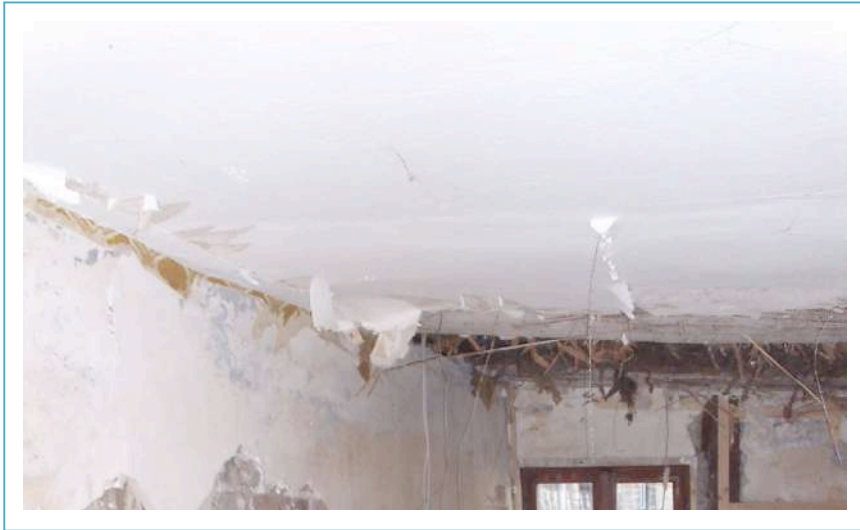
Due to its proximity to a stream, the building stands on a subsoil of peat fill, which has no load-bearing capacity for buildings. Only at a depth of 4m or more is there natural subsoil. Over the centuries, the building has been subject to strong vertical and horizontal deformations. The maximum deformation from the front of the house to the courtyard side was approx. 30 - 40 cm. Due to the narrow foundation width on the courtyard side; the foundation has given way due to ground failure. Damage was evident on almost all wooden structural elements. In addition, alterations carried out in the 19th century produced an internal room division with a low storey height of only 2.05 m in some cases, which posed a great challenge for residential use.

*Image No. 3, upper floor with deformations
and low room height, © LAKD M-V, LD, Jan Schirmer*

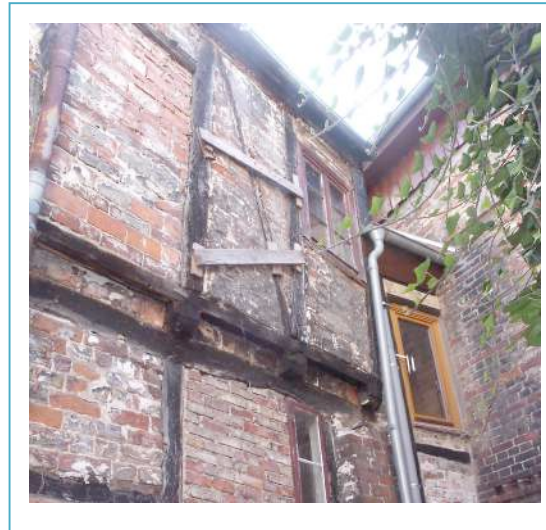
*Image No. 5, courtyard facade, upper floor with
traces of reconstruction and partly original infill,
original supporting post © LAKD M-V, LD, Jan Schirmer*

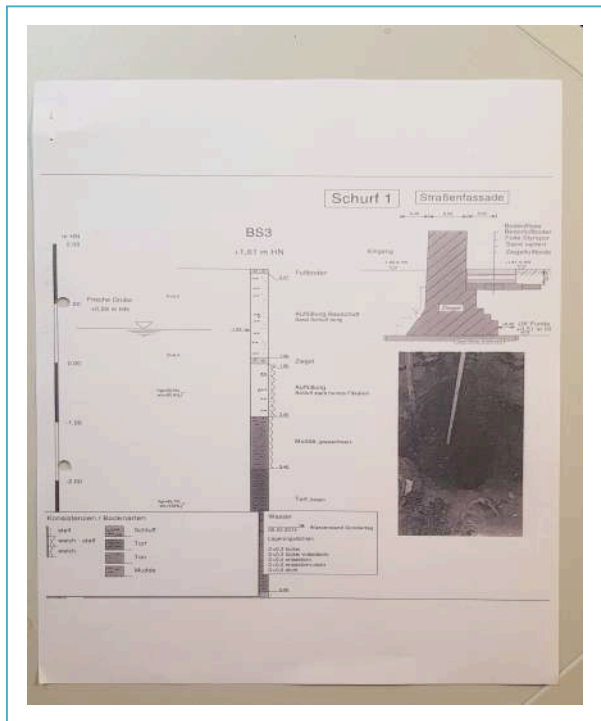
Soil survey: The exploratory excavation 1 in Fig. 8 shows an example of the structure of the ground: The foundation on the street side and courtyard side features a step-like widening of the foundation. In addition, a wooden grate was found on the street side, which is located below the foundation stepping. As a result, there is less settlement on the street side than on the courtyard side. Due to the narrow foundation width on the courtyard side, the foundation here has given way due to ground failure.

Image No. 8, exploratory excavation 1 with soil structure, © Soil survey, Windhorn Engineers, Wismar, 2014

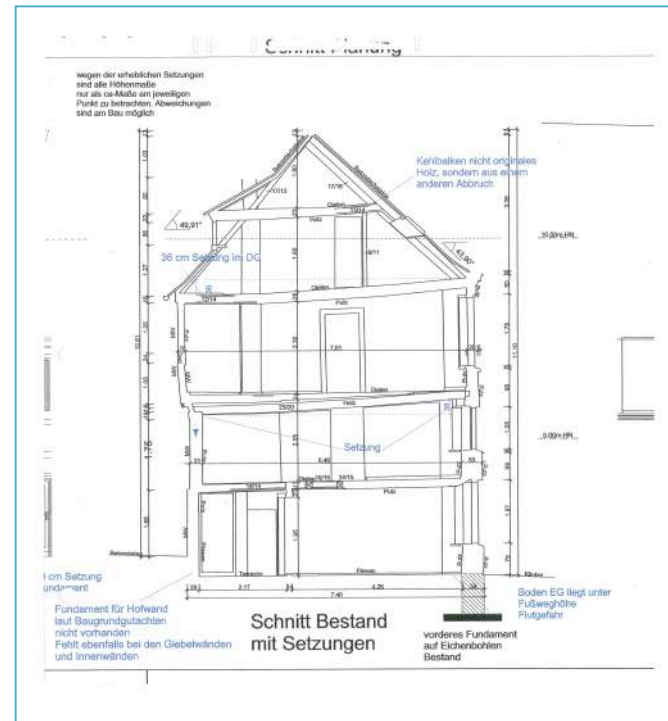
Image No. 9, building section with settlements, © Soil survey, Windhorn Engineers, Wismar, 2014

As the building stands on a subsoil with no load-bearing capacity, the complete load-bearing capacity had to be achieved by retrofitting the foundation with micropiles. For this purpose, 24 auger piles were placed at a distance of approx. 35 cm from the outer walls.

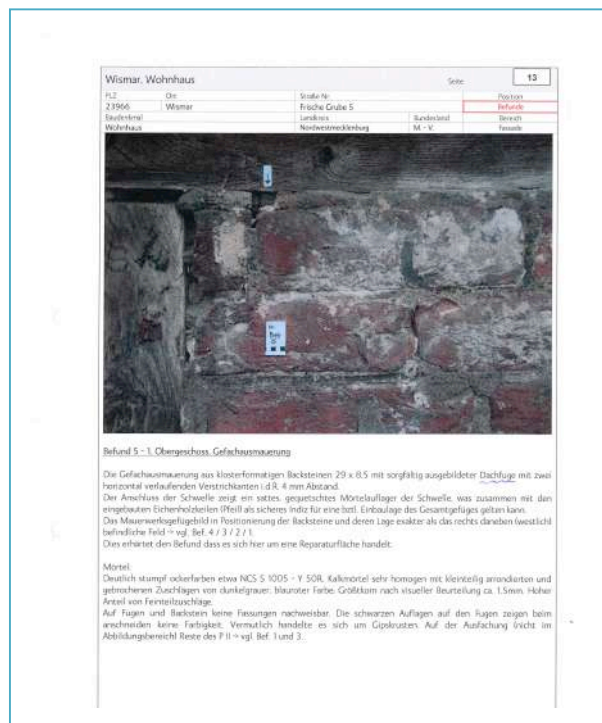
Restoration examination: On the upper floor, there are still brick infills from the construction period (large bricks in cloister format 28/28.5 x 12/13 x 9 cm), which were laid with lime mortar and carefully slushed-up roof joints. Originally, the appearance was one of brick with a lime slurry. There was no evidence of coloured finishes. Figure 10 shows the masonry filling of cloister-format bricks with a carefully formed roof joint with two horizontally running coating edges at an average distance of 4mm. The connection of the sill shows a well-set, crushed mortar bearing of the sill, which together with the installed oak wedges (arrow in Fig. 11) can be regarded as a sure indication of that this was the installation position of the overall structure dating from the building period.

Image No. 10, masonry filling, 1st upper floor,
 © Restoration examination, Lange, Wismar, 2015

In areas where the connection joints between the brick infill and the beams were loose or missing, the infill was additionally fixed with slender oak wedges. The wedges were installed in such a way that they grip against the brick and the beam. In areas where the edge joint was intact, it was left in place. After wedging, the connecting joints (defects) were sealed with a weak hydraulic lime mortar. Washed, crushed sand with a grain size of 0-2 mm was used as sand for a better grip, calf hair was added for reinforcement. The joint groove was cleaned (blown out, sprayed out), then the mortar was tamped in in layers, earth-moist, to achieve the best possible traction.

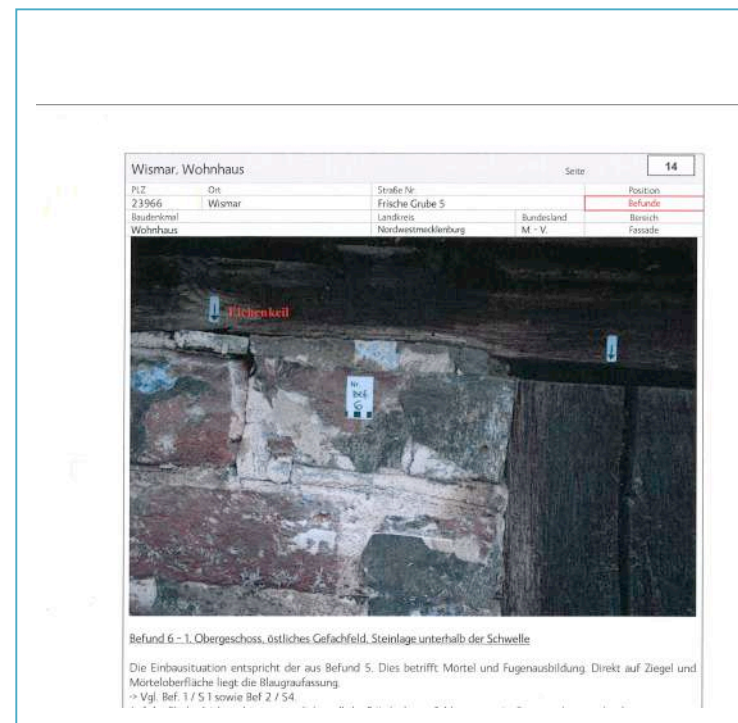
Image No. 11, 1. 1st upper floor, eastern compartment field,
 stone layer below the sill,
 © Restoration examination, Lange, Wismar, 2015

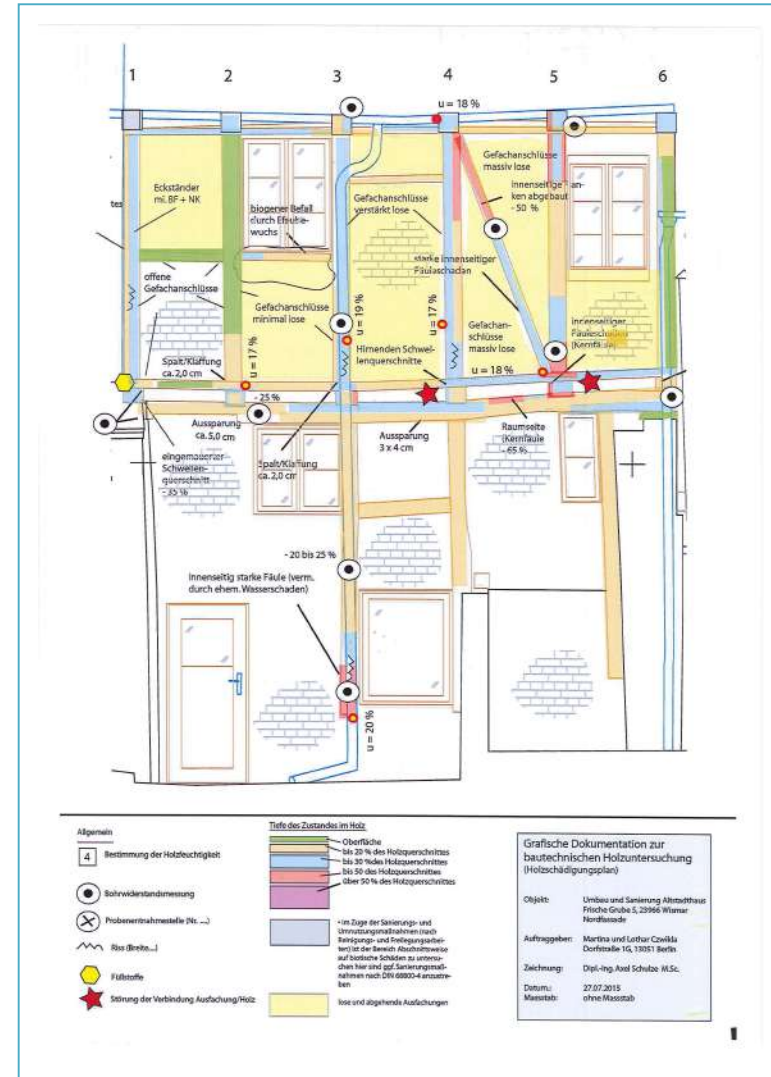
Image No. 13, timber damage plan,
© Restoration examination, Lange, Wismar, 2015

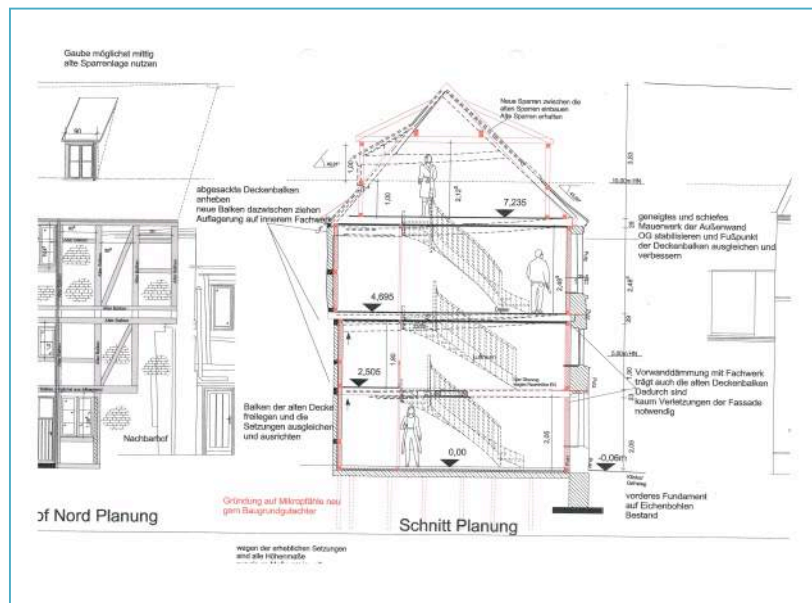
Image No. 14, planning of the house-in-house construction with micropiles, © Soil survey, Windhorn Engineers, Wismar, 2014

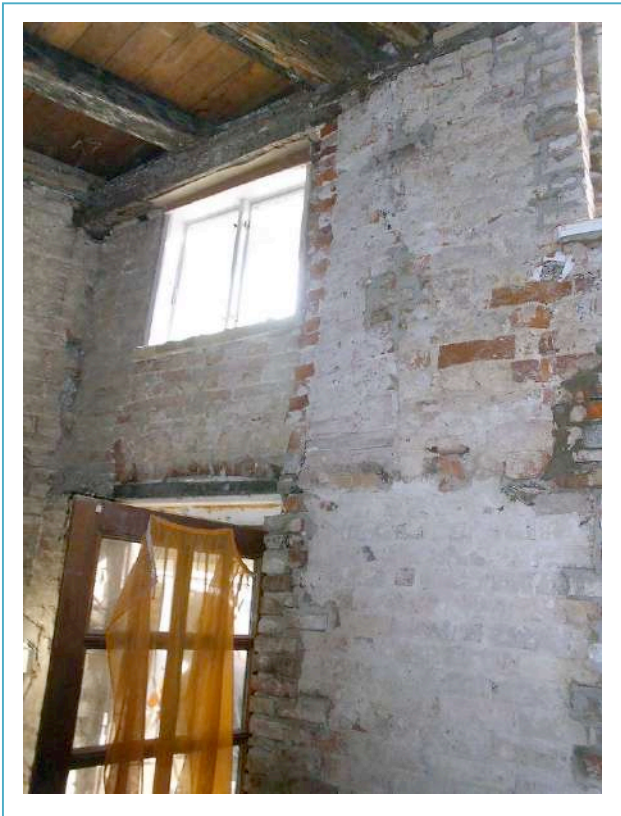
The original half-timbered construction had been completely replaced by solid masonry on the street side (Fig. 15). The half-timbering was only braced by means of angle braces and cogged ceiling beams, and the floorboards had been largely replaced. The structural engineer's idea was to create a wooden framework (Fig. 16) in the interior that would add little load, which was largely decoupled from the self-supporting exterior walls and at the same time accommodated insulation and the new loads of use.

*Image No. 15, street facade with head rail of the former timber frame construction,
© LAKD M-V, LD, Jan Schirmer*

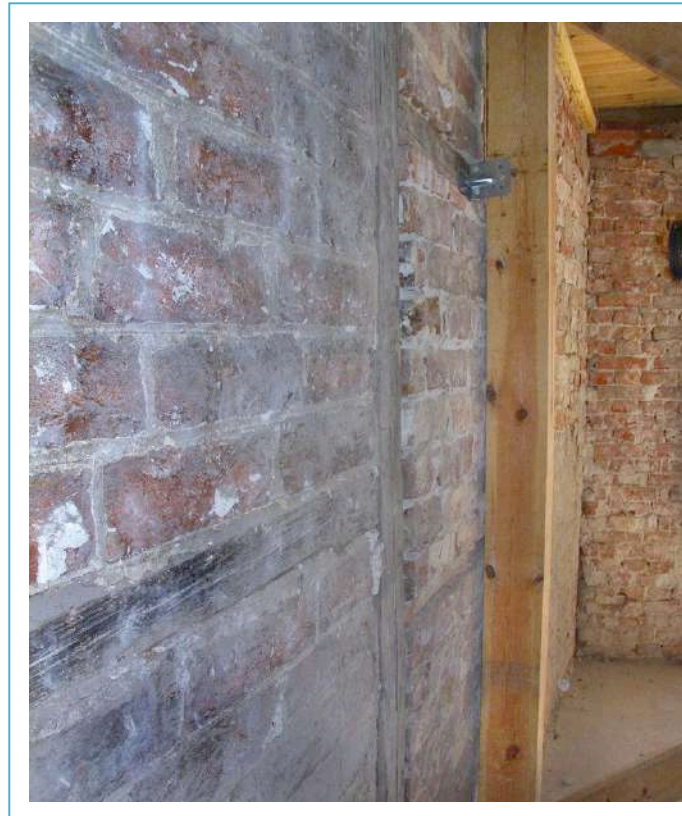
*Image No. 16, the eastern gable wall with half-timbered construction,
© LAKD M-V, LD, Jan Schirmer*

On the eastern gable wall, a frame construction was carried out on the 1st and 2nd floor in order to be able to visibly experience the medieval masonry. A connection of the historic gable wall to the new supporting interior construction was not statically necessary. The medieval house corners, which were structurally built together with the neighbouring houses, did not have to be underpinned. The new interior supporting framework was set in a regular grid of approx. 65cm spacing according to static specifications.

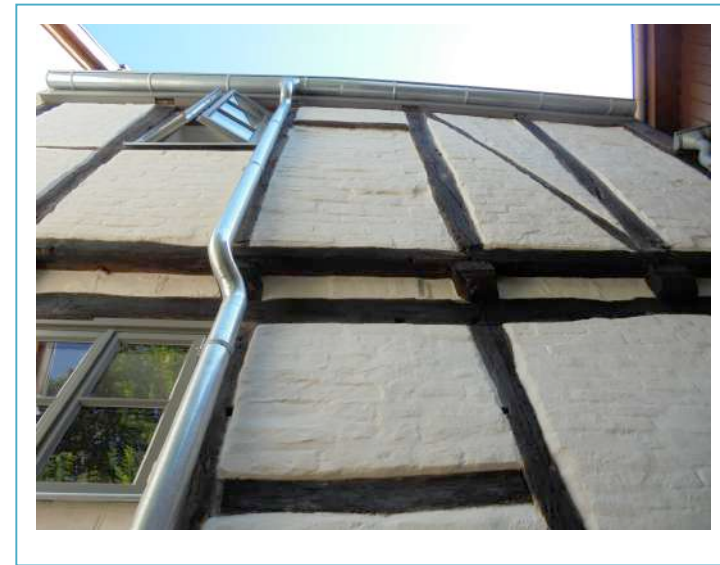
*Image No. 18, courtyard facade after sanitation, 2016
© LAKD M-V, LD, Jan Schirmer*

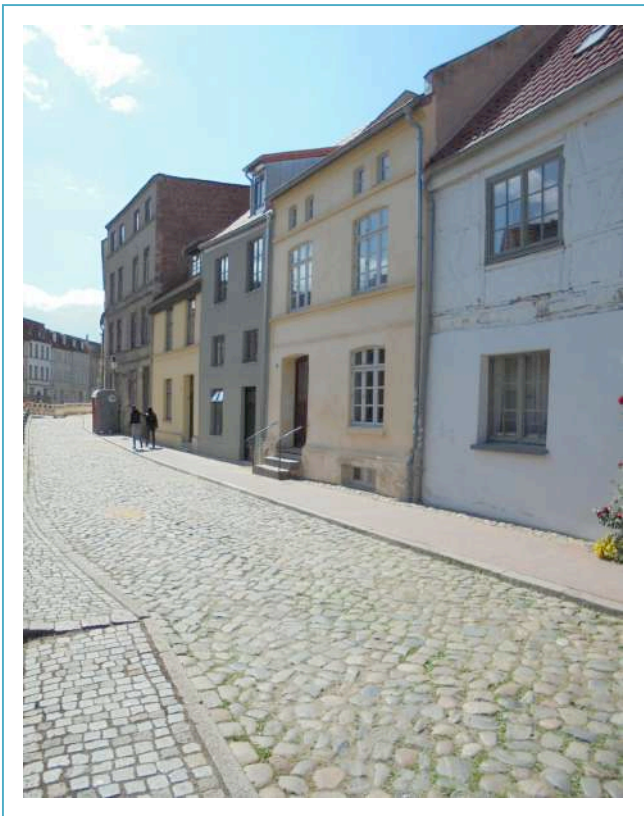
*Image No. 21, building condition after restoration, 2016 (grey facade),
© LAKD M-V, LD, Jan Schirmer*
