**B**ALTIC REGION HERITAGE COMMITTEE

## Good practices on built heritage conservation/restoration

### *Haapsalu Castle.*

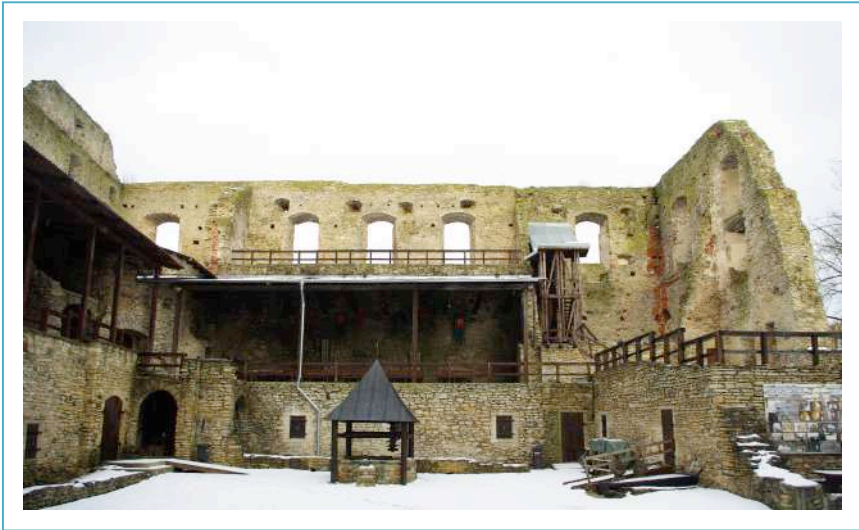
*Image No. 3, Before the works. In 2014, the castle walls and later additions were in emergency condition. Photo SALM.*

Since the 17th century, the main castle has been in ruins. There was never enough scientific data to restore the medieval volume of the castle, so it was not done in 1950s nor in 1980s. Still, the construction work in 1980s destroyed some of the strata of the courtyard as well as some historical structures. Now, the absolute priority was the conservation of the castle and its content to the highest level possible. From here, a number of fundamental issues emerged. How many of the previous additions and reconstruction works could be removed? How much new architecture could be added and what materials should be used? But

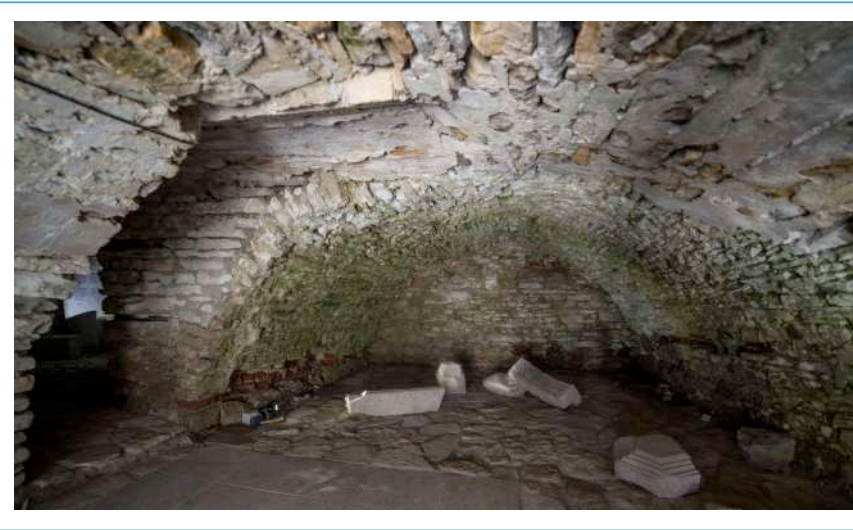
*Image No. 4, Cellar like interiors were dark and without heating. Photo SALM.*

The creation of a modern museum environment in the medieval castle required a great deal of planning and research. For example, how do you create a sustainable and museum-friendly indoor climate in a building that was last heated in the 17<sup>th</sup> century? In order to solve this question a cooperation with the Institute of Building Design of Tallinn University of Technology was established, whose study on ensuring the indoor climate became the basis for further heating and ventilation design work.

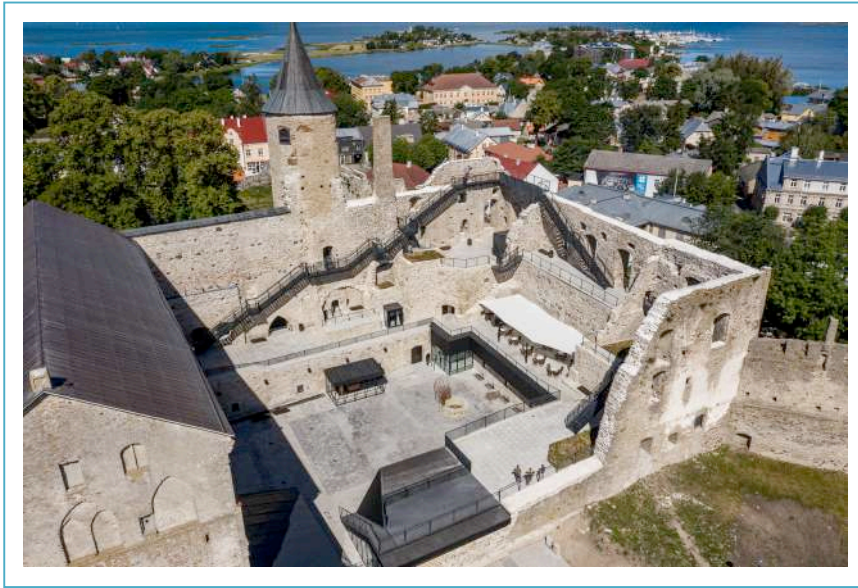
*Image No. 7, renewed museum in 2019. Photo SALM/Tõnu Tunnel.*

The pathway is like a flowing band, guiding guests on a journey of impressions from the present and the past. Its bridge-like structure has been attached to the walls by means of steel cantilevers, which were placed to minimise any damage to the historical stonework. For example, architects made use of wall parts that already had anchorage points for the roof structure, originating from the renovation in the 1990s, or attached the bridge to those parts that had been reconstructed earlier. For the bridge to be lightweight, the pathway was made of sheet steel.

The most resonant detail was the new staircase running along the walls of the main castle, in both the design phase and in the building phase. When completed, it is perhaps the biggest change in the complex. The staircase on the walls has opened up new views of both the castle and the city and climbing the walls via the staircase gives a better idea of the castle's former size.

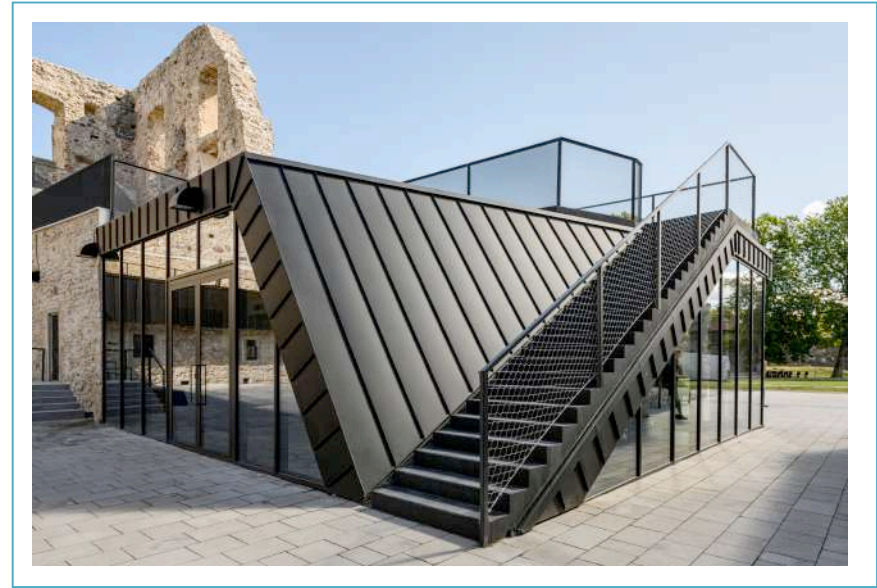
*Image No. 8, the new entrance pavilion. Photo SALM/Tõnu Tunnel.*

How much new architecture could be added and what materials could be used? The goal was to add as little as possible, just enough to open the walls of the castle to visitors. All the new additions are clearly modern, made of glass and metal. The biggest addition was the new entrance pavilion, the volume of which was determined by the previously reconstructed east wing of the fortress. This solution is also spatially justified: it connects different levels, ensuring access to the basement, ground level and the roof, thus serving as the beginning and end point of the museum visit.
