BALTIC REGION HERITAGE COMMITTEE

Good practices on built heritage conservation/restoration

Agency for Cultural Heritage Management in Bergen.

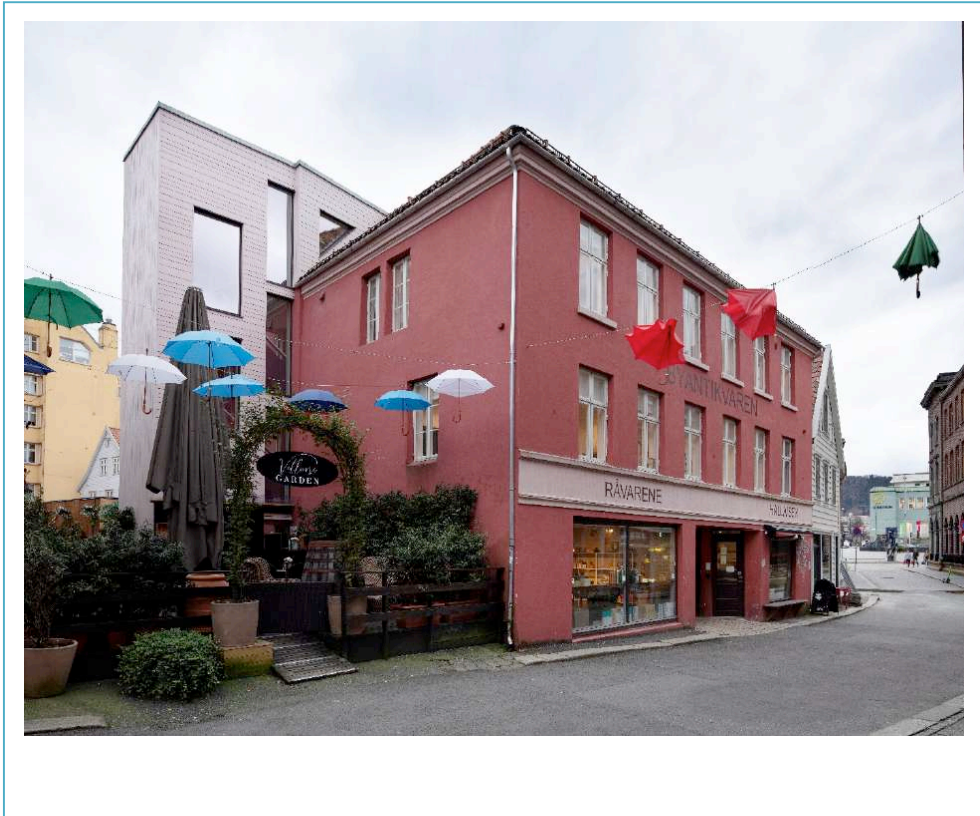
*Image No. 1, The Agency for Cultural Heritage Management in Bergen, the façade seen from the intersection of Skostredet and Sparebankgaten.
Photo: Trond A. Isaksen, Directorate for Cultural Heritage.*

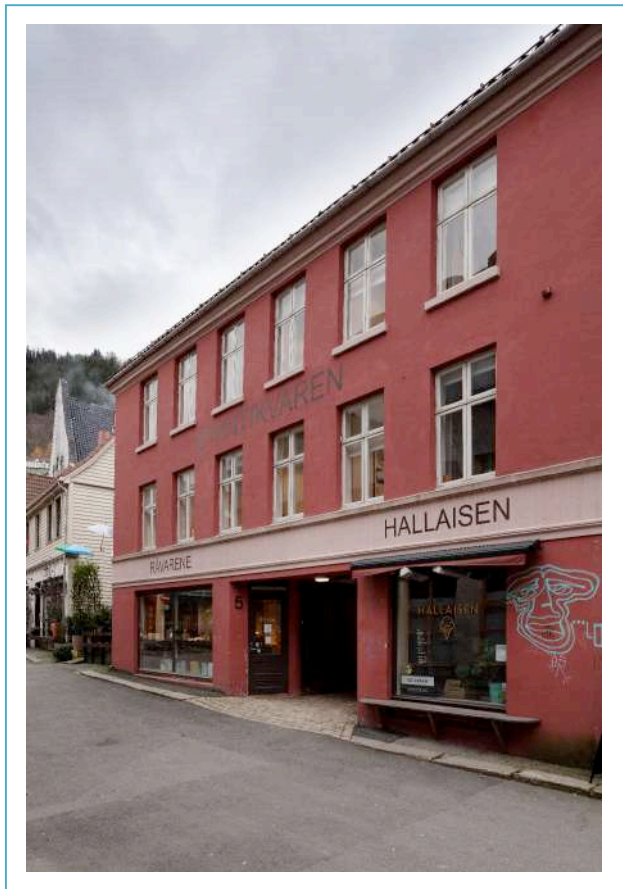
*Image No. 3, The Agency for Cultural Heritage Management Office in Bergen.
Façade seen from Skostredet and Bankgaten.
Photo: Trond A. Isaksen, Directorate for Cultural Heritage*

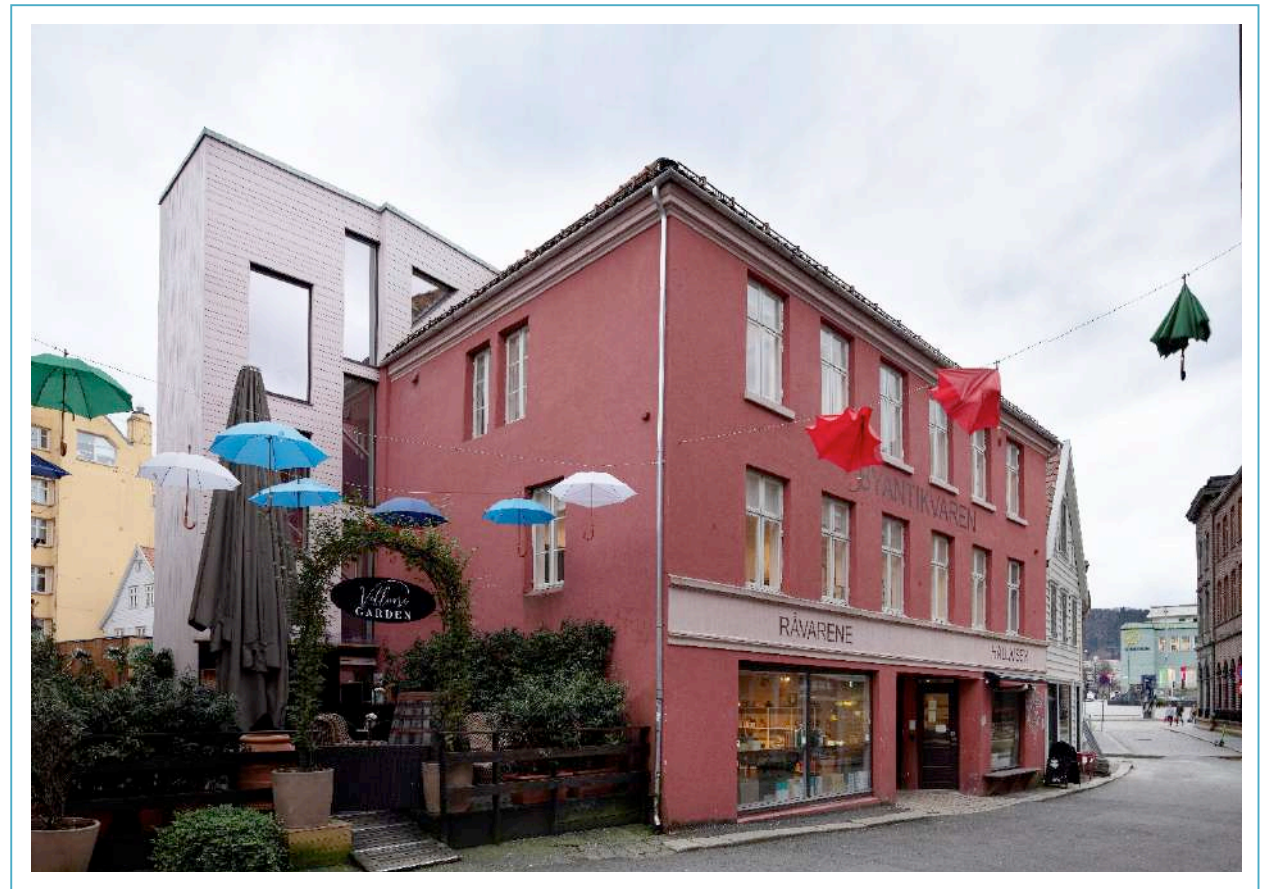
*Image No. 4, The Agency for Cultural Heritage Management Office in Bergen, showing the contrast between old and new sections of buildings.
Photo: Trond A. Isaksen, Directorate for Cultural Heritage.*

A new design has replaced the old open portico that was in poor condition. This used to be the communicating link between the buildings. During the project, the old open portico was replaced with a new open portico, which also highlighted the differences in floor height between the buildings.

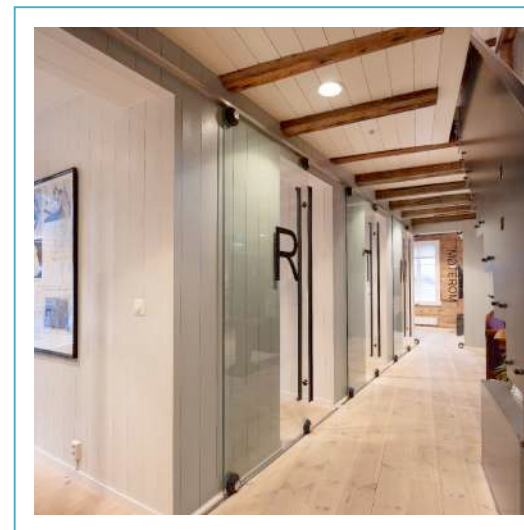
Image No. 6 The Agency for Cultural Heritage Management Office in Bergen, corridor with new sliding glass doors. Photo: Trond A. Isaksen, Directorate for Cultural Heritage

The picture shows new sliding doors into the offices. These have an industrial expression that complements other new elements such as new stairs and handrails. Eskil Tin was responsible for the Blacksmithing and glasswork.

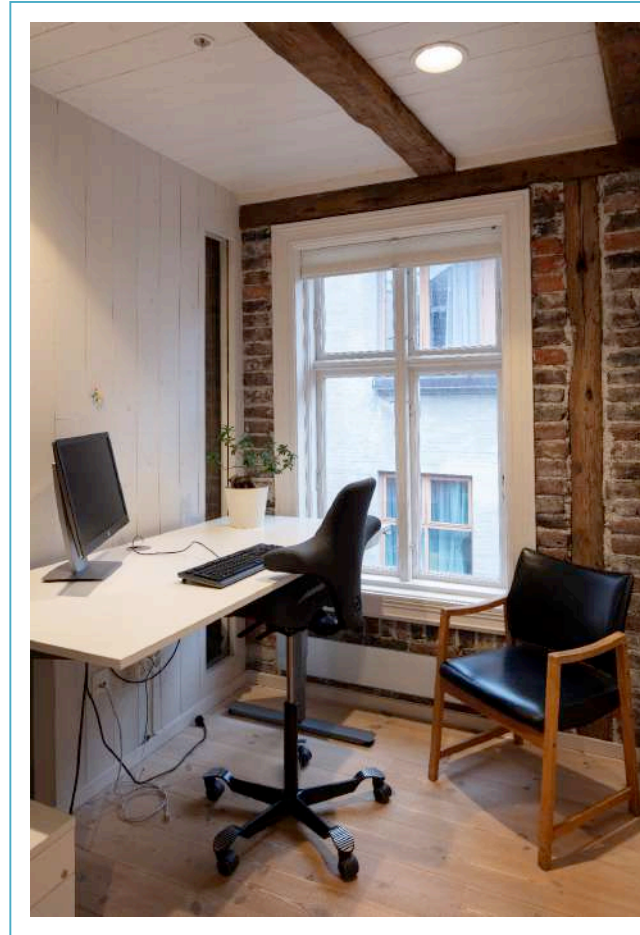
Image No. 8 The Agency for Cultural Heritage Management Office in Bergen. Office with half-timbered walls. Photo: Trond A. Isaksen, Directorate for Cultural Heritage

This would be done by showing the various principles of how the different buildings are built and how they function. The project emphasised identifiable material use, construction principles and details – including timber that has been cog jointed by hand and by machine, and also half-timbered walls.

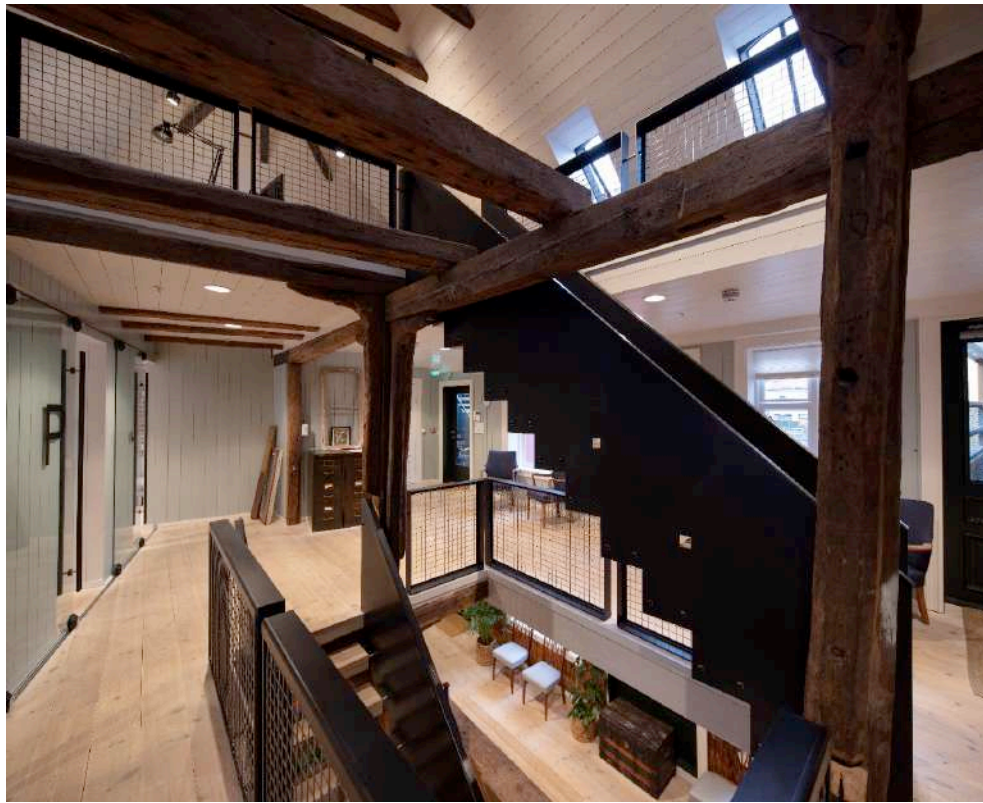
Image No. 9 The Agency for Cultural Heritage Management Office in Bergen, staircase and exposed load-bearing system on the 2nd floor. Photo: Trond A. Isaksen, Directorate for Cultural Heritage

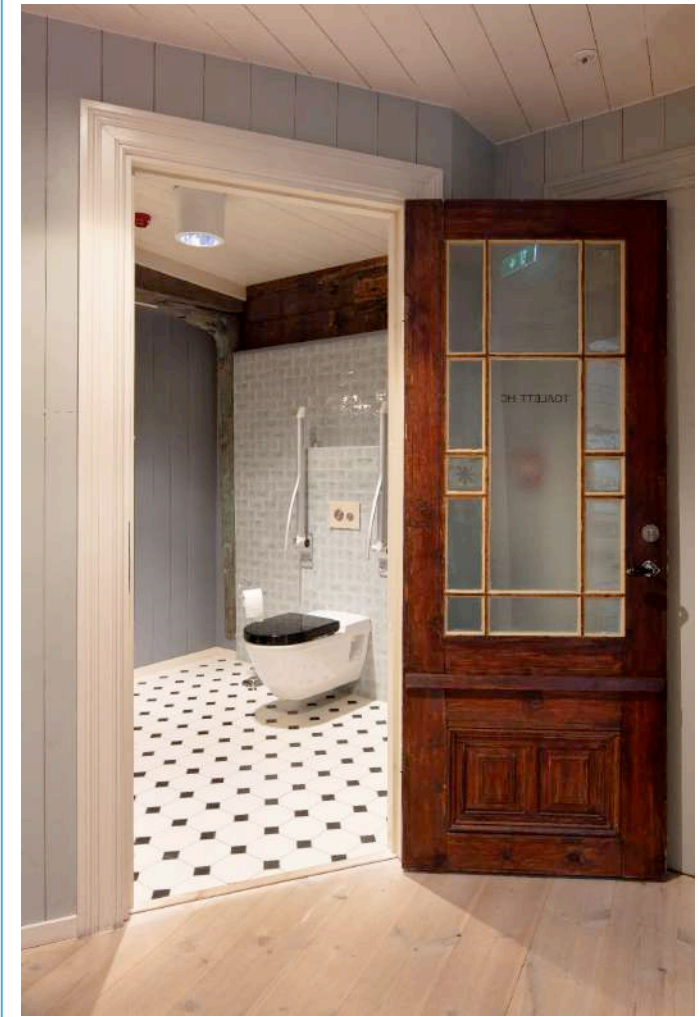
Image No. 10 The Agency for Cultural Heritage Management Office in Bergen, old door into the new toilet. Photo: Trond A. Isaksen, Directorate for Cultural Heritage

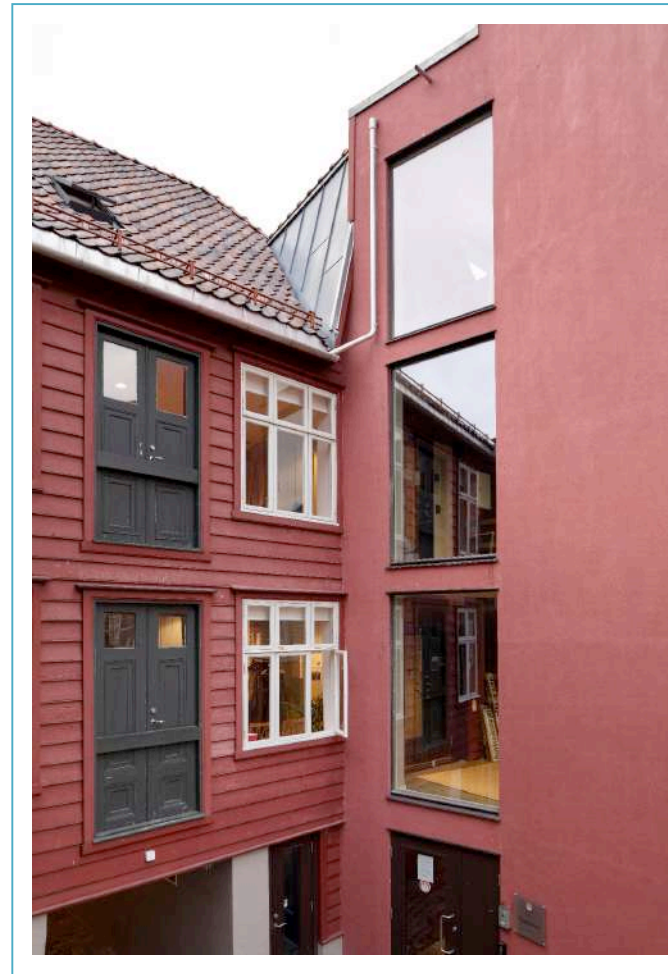
*Image No. 16 The Agency for Cultural Heritage Management in Bergen,
new and old sections of buildings meet in the corner facing the backyard.
Photo: Trond A. Isaksen, Directorate for Cultural Heritage*

A lift/stairwell has been 're-established' where there used to be an extension facing the backyard (Stables). This serves all floors and ensures that the areas open to the public meet universal design requirements. All the other facades are pretty much unchanged.
