BALTIC REGION HERITAGE COMMITTEE

Good practices on built heritage conservation/restoration

Wodociąg (Muzeum Łazienki Królewskie w Warszawie) / The Water Tower (Royal Łazienki Museum in Warsaw).

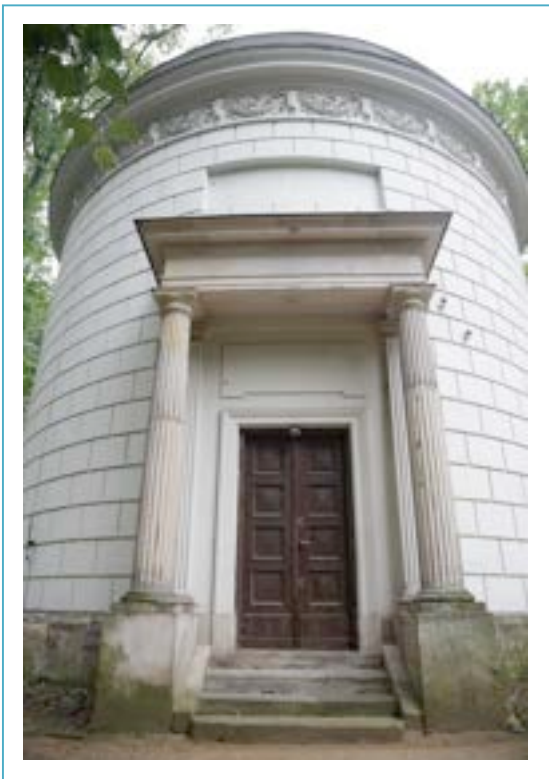
Image No. 2, Elevation before the conservation, photo by Marta Boguta

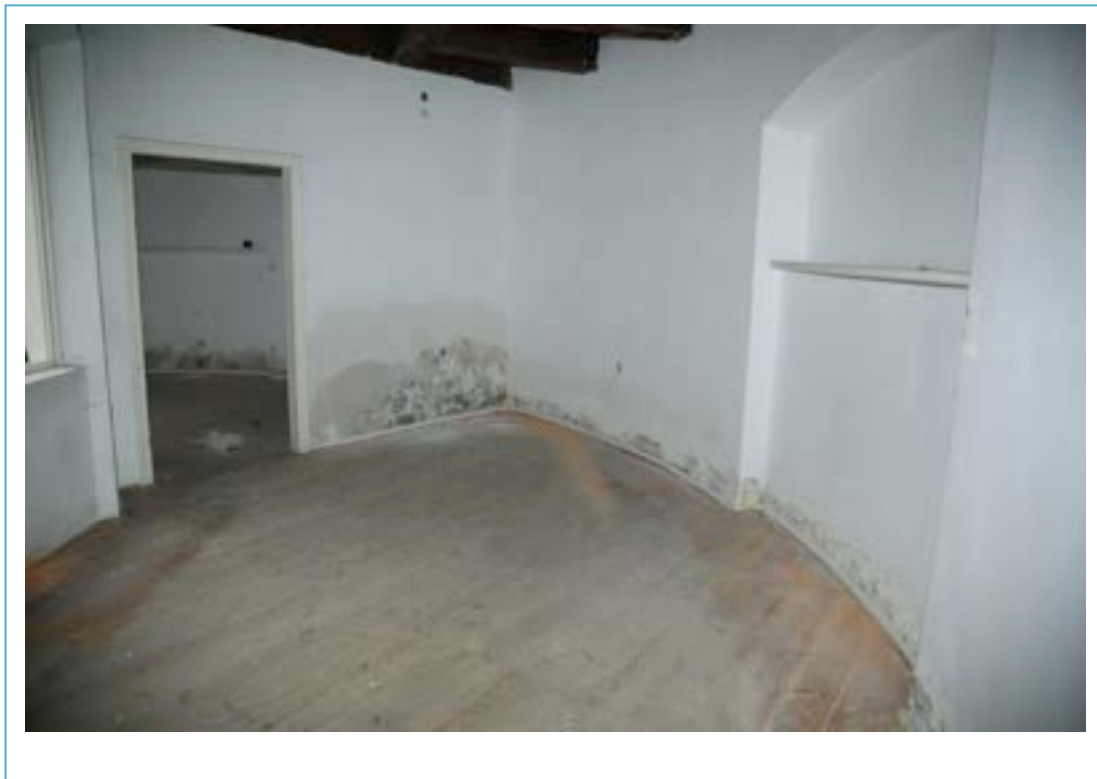
Image No.3, Ground floor before the conservation, photo by Marta Boguta

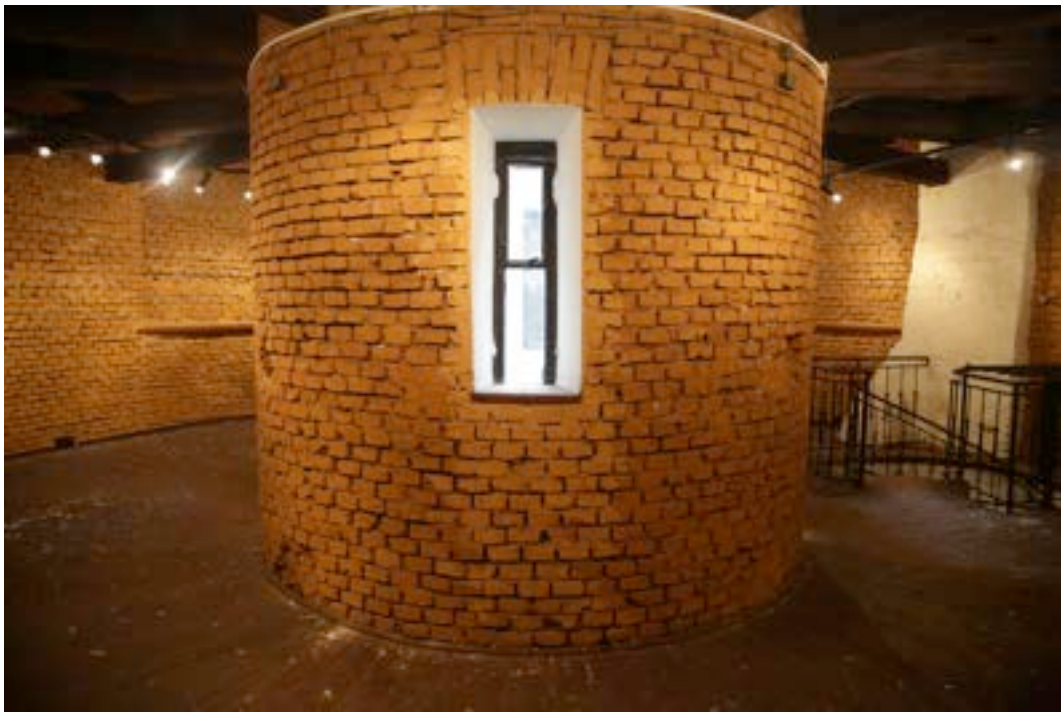
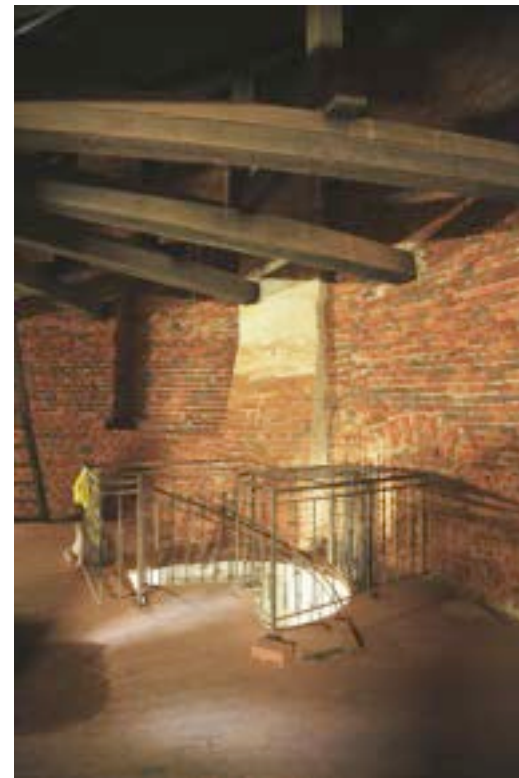
*Images No. 6, 7, First floor before the conservation,
photo by Marta Boguta*

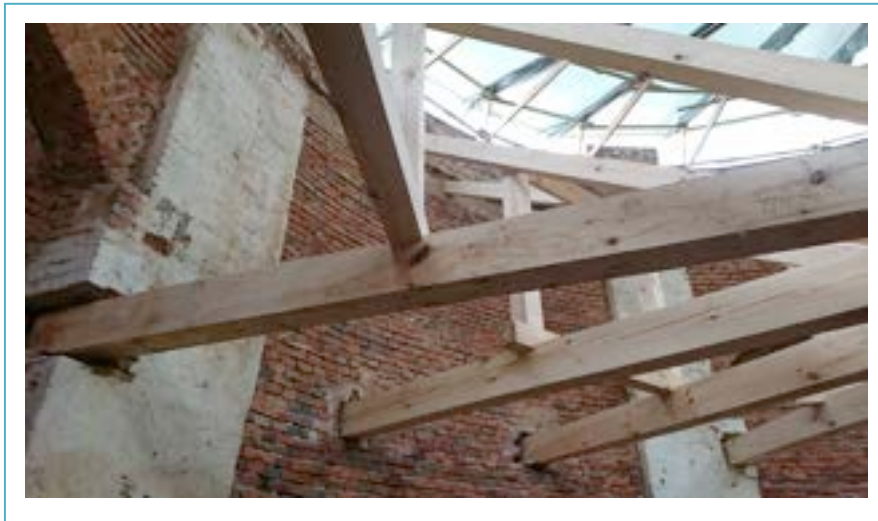
*Image No. 8, Roof truss during the conservation,
photo by Maciej Czyski*

Following the model of the stairs in the Palace on the Isle, cast-iron stairs leading to the first floor of the building were reconstructed. The roof covering and the secondary structure were also replaced, while preserving the original system of water drainage in form of a "funnel".

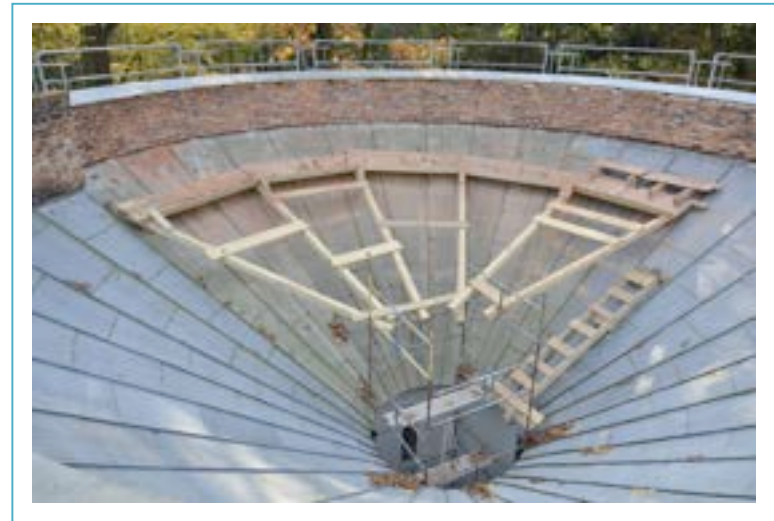
*Image No. 9, Roof during the conservation,
photo by Maciej Czyski*

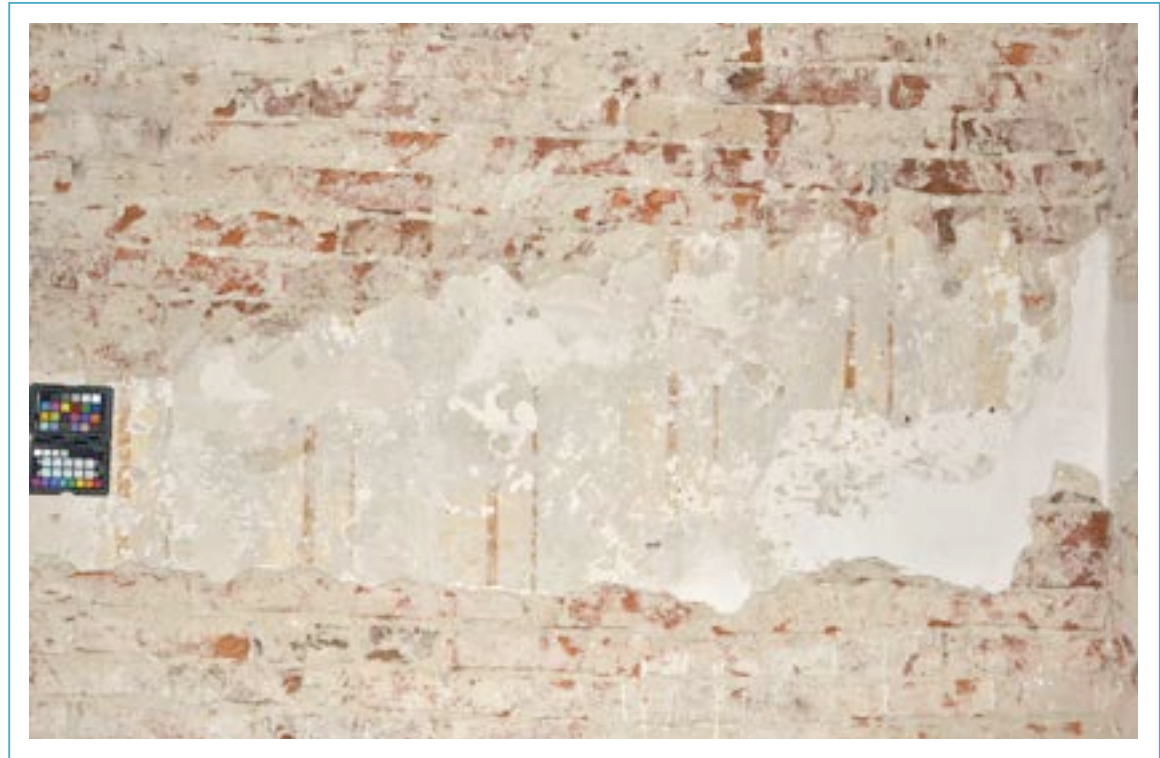
Image No. 11, Ground floor – wall polychromes, photo by Marta Boguta

Another conservation challenge was to highlight the polychromes, both the original and reconstructed layers, using historical techniques and binding materials. In two rooms, the decoration of the walls was reproduced and the original relics of 18th-century polychromes were highlighted.

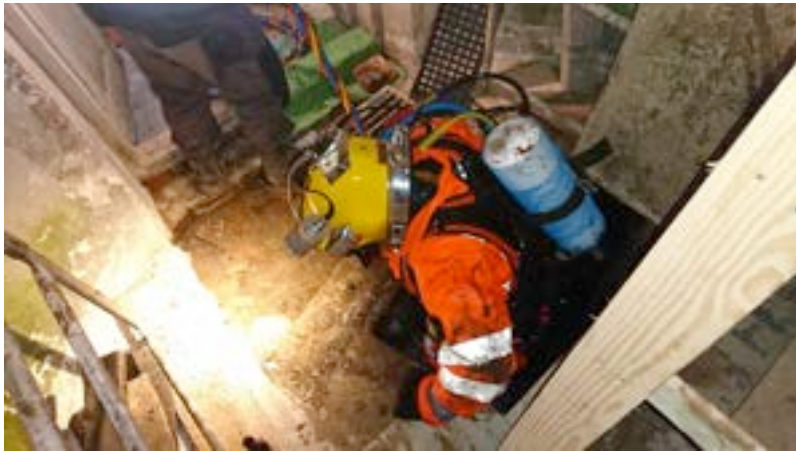
*Image No. 12, Underwater exploration,
photo by Maciej Czynski*

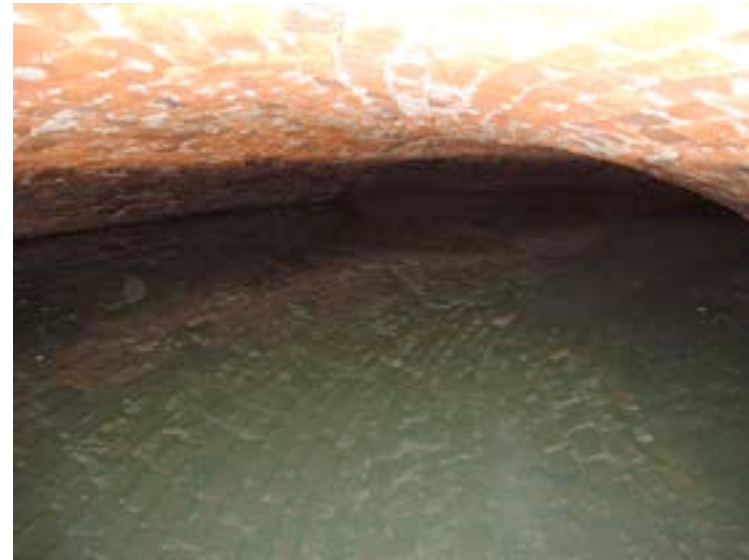
*Image No. 13, Reservoir tank underneath the ground floor,
photo by Dorota Śliwińska*

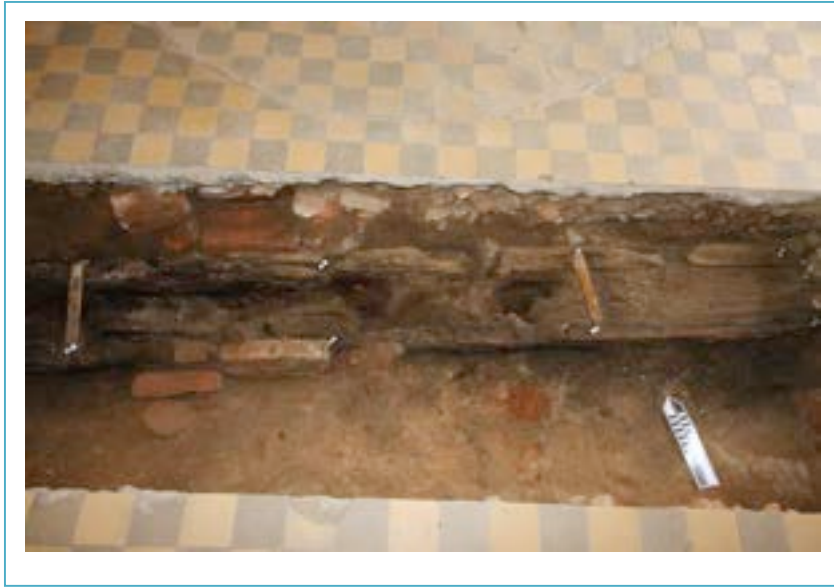
*Image No. 14, Wooden gutter found during excavation
photo by Marta Boguta*

challenge. Eventually, it was decided to display these elements in their original locations, after applying conservation measures and adapting the insulation layers or wall coverings to the elements uncovered.

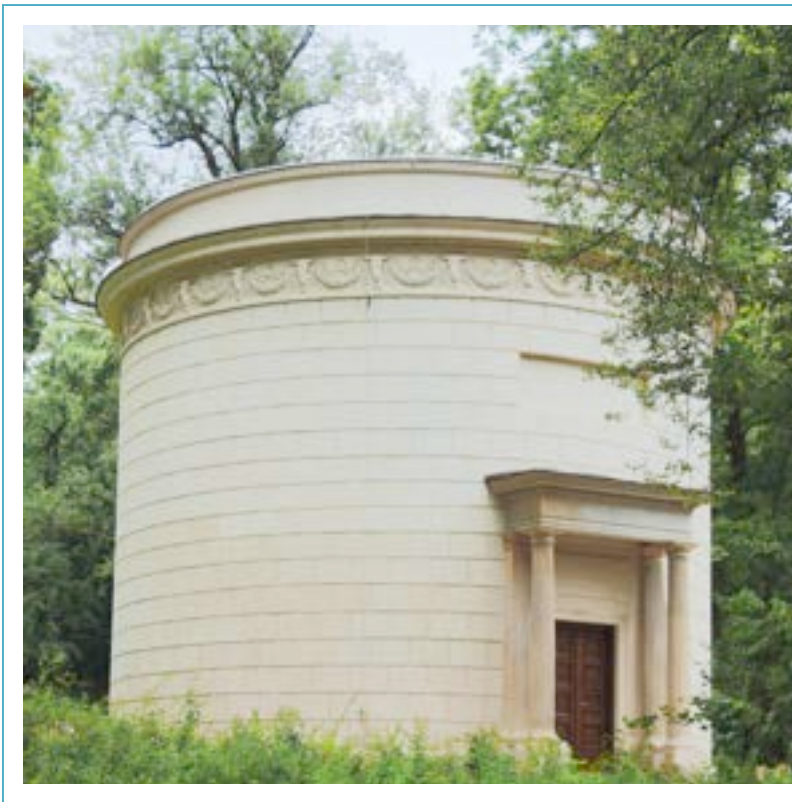
Image No. 16, The Water Tower after the conservation, photo by Paweł Czarnecki

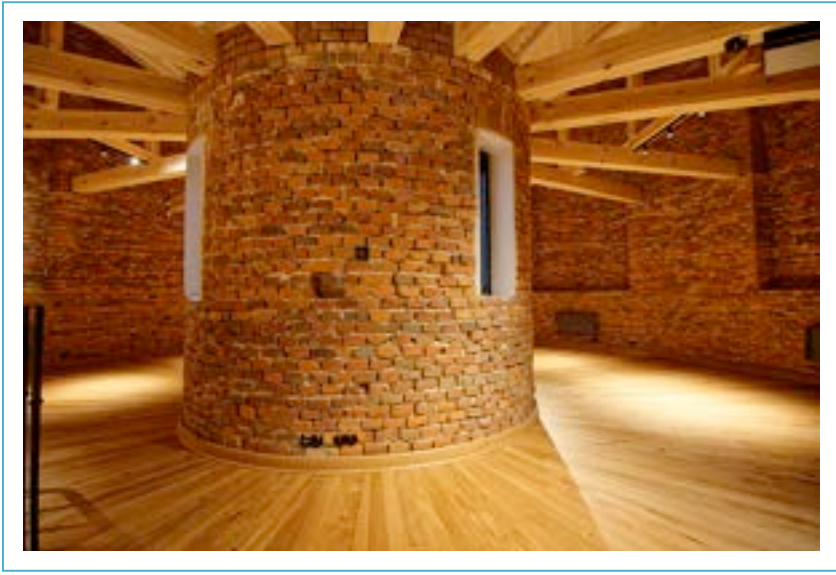
Images No. 24, 25, First floor after the conservation, photo by Maciej Czyski

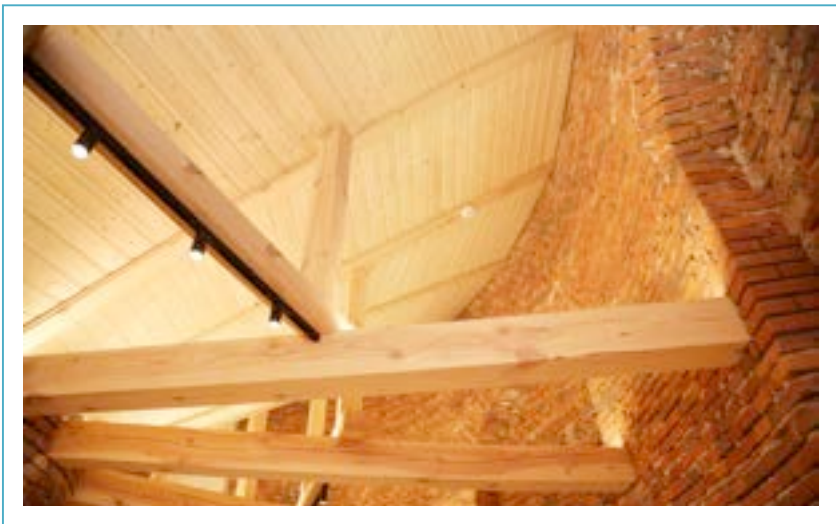
Image No. 26, Roof truss after the conservation, photo by Paweł Czarnecki
