BALTIC REGION HERITAGE COMMITTEE

Good practices on built heritage conservation/restoration

S:t Görans gymnasium, Stockholm, Sweden.

S:t Görans gymnasium (S:t Göran high school), Stockholm. Completed 1960 and rebuilt 2015-18 to accommodate student housing and a preschool.

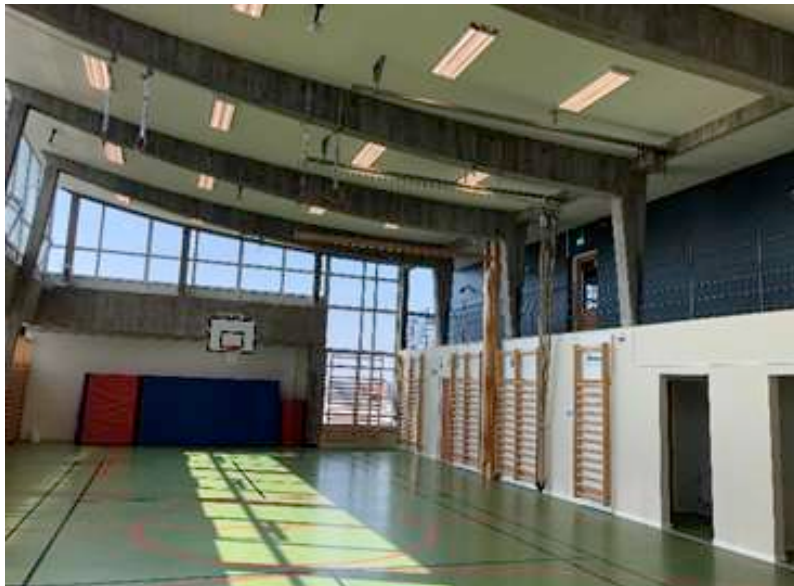
(Left): The gym on the topfloor of the building. Photo: Cathrine Mellander Backman, RAÄ, 2021.

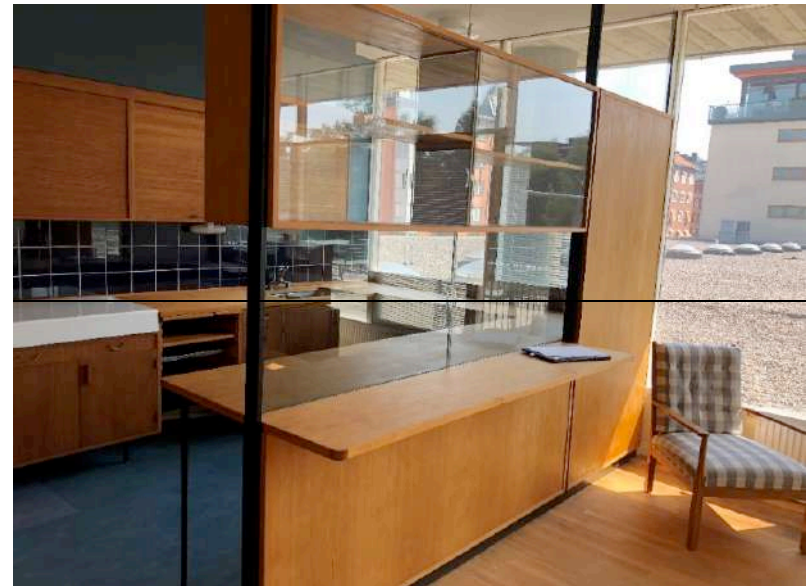
(Right): The kitchen in one of the apartments used for practical training, today turned into a museum. The materials and the quality in performance characterize the building. Photo: Cathrine Mellander Backman, RAÄ, 2021.

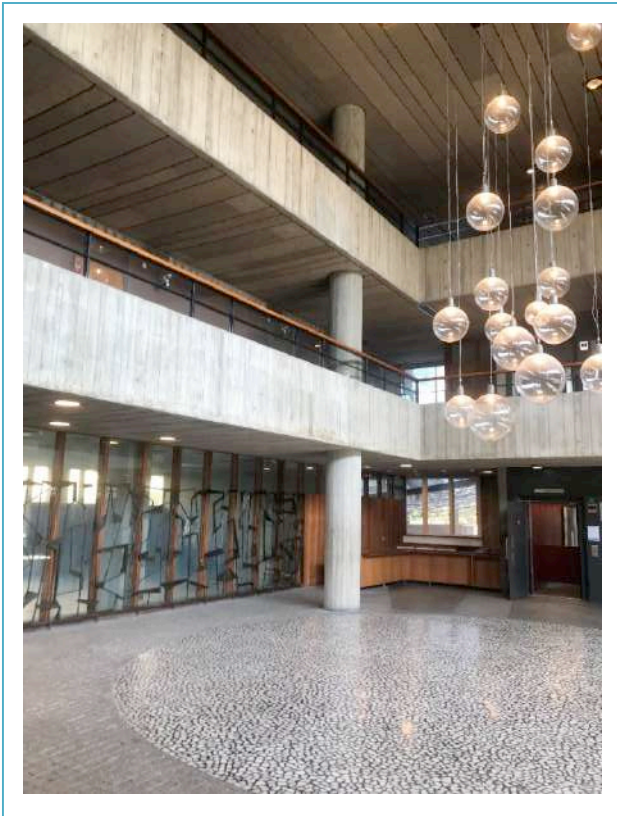
(Left): The raw concrete, the decorative ironwork, the luminaire and the floor and ground covering in the three floors high open entrance hall, all contribute to the building's unmistakable character. Photo: Eva Dahlström Rittsél, RAÄ, 2021.

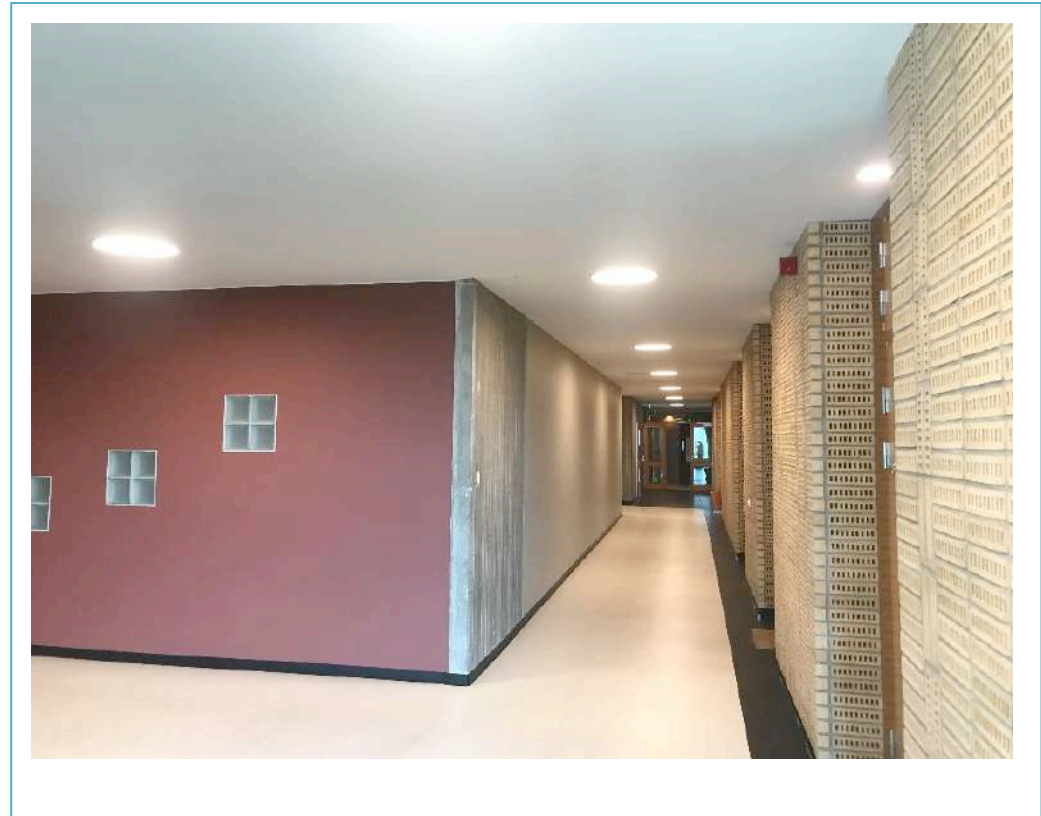
(Right): An apartment corridor with new brick walls in yellow hollow brick. Photo: Eva Dahlström Rittsél, RAÄ, 2021.

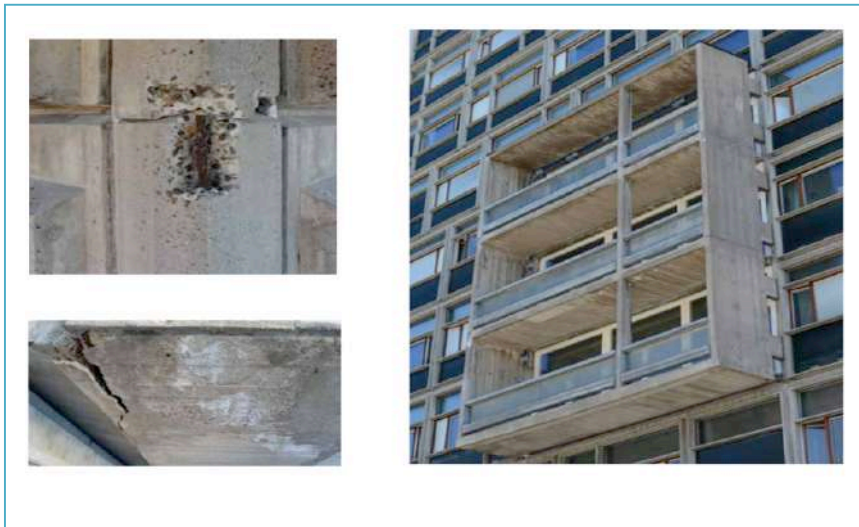
*Injuries on the concrete elements and on the balconies in concrete.
Photo: Sven Olof Ahlberg.*

An important goal of the work was to preserve as much of the original materials as possible and, where measures were necessary, to carry out the work with great care and adaptation to the original materials and methods. When the restoration began, the building had been empty for a number of years and the maintenance had been neglected. The damage was inventoried, photo-documented and categorized into three levels. The facades with prefabricated concrete elements with glass had extensive damage as well as the balconies. Other interventions that needed to be carried out was to restore plaster damage and leaking roofs and secure the stairs and the roof terraces. The windows, with low noise- and energy values, had to be adapted to standards of today.

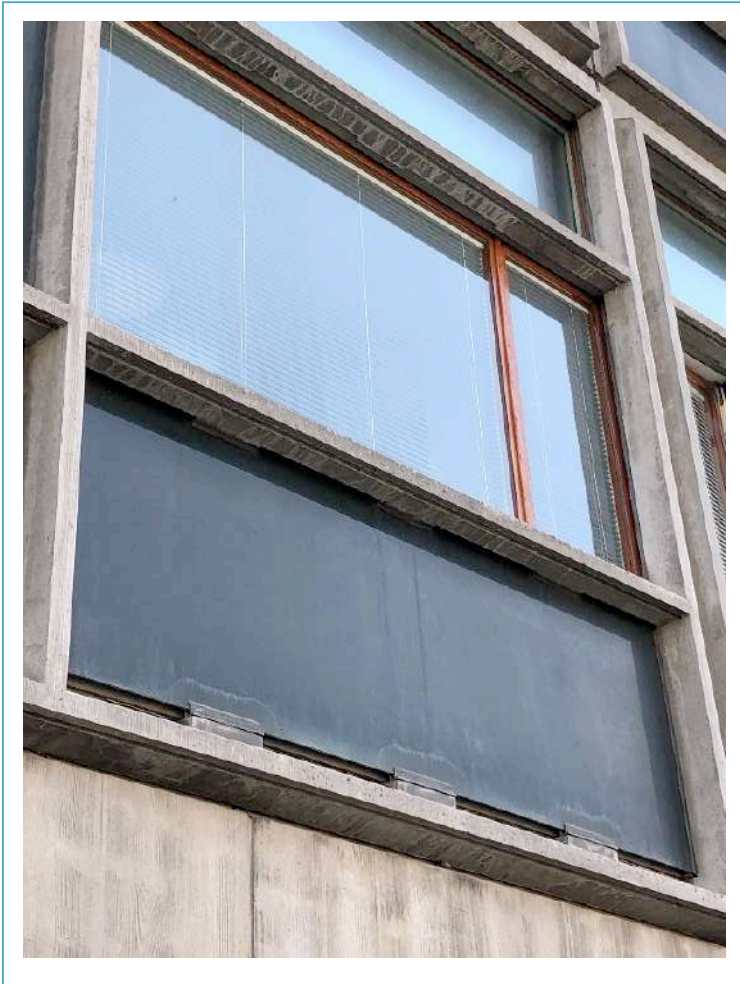
The facade with concrete elements, glass and windows. Photo: Cathrine Mellander Backman, RAÄ, 2021.

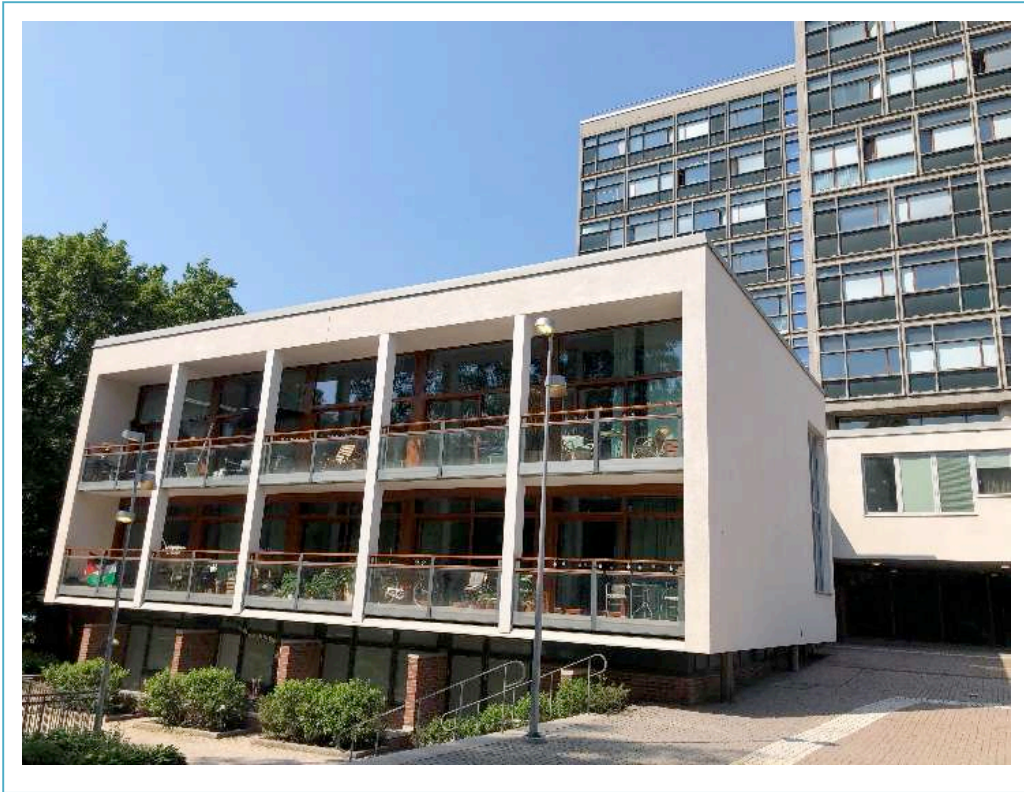
(Left): The new building with apartments, replacing the never executed auditorium by the inner square. Photo: Cathrine Mellander Backman, RAÄ, 2021.

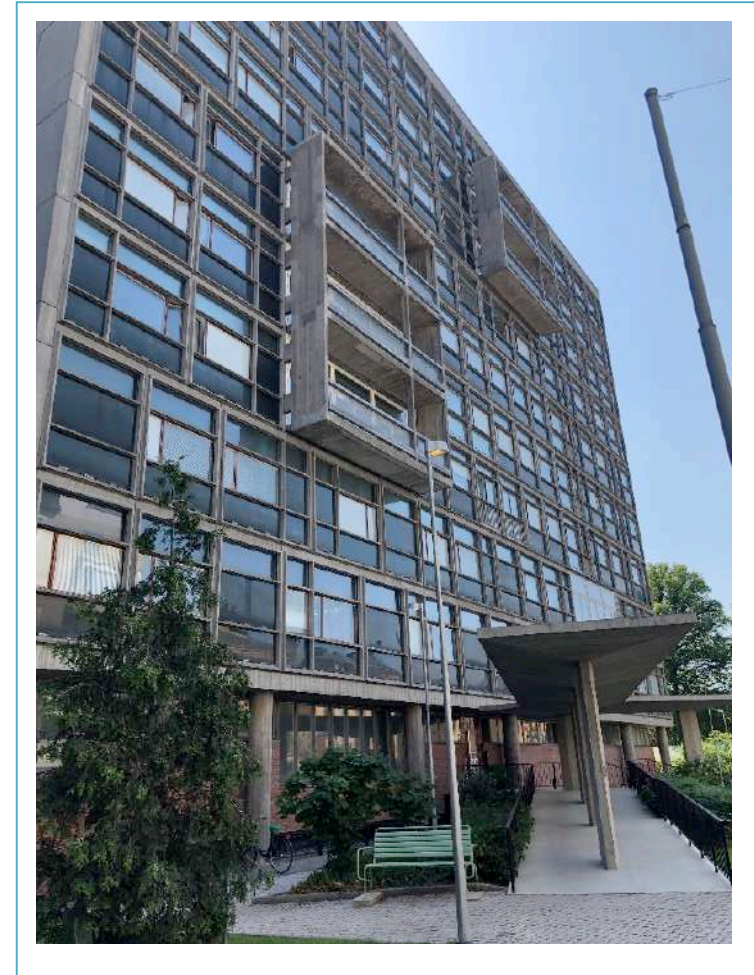
(Right): The new entrance from Mariebergsgatan. Photo: Cathrine Mellander Backman, RAÄ, 2021.

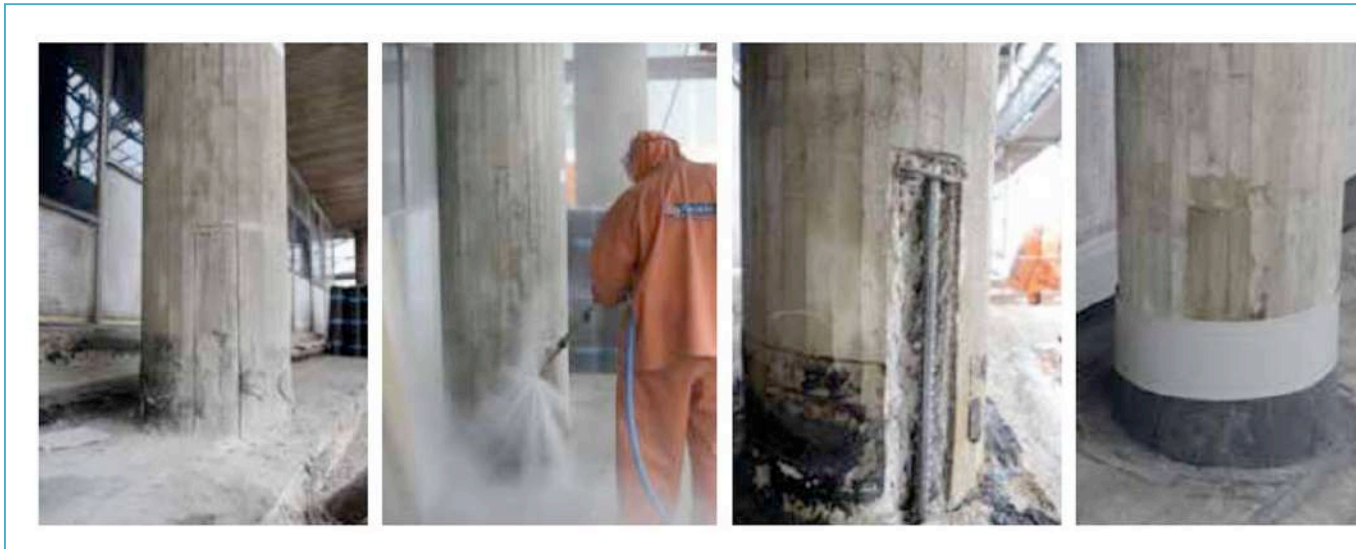
Restoration of the pillars, water blasting and casting of new concrete. Photo: Sven Olof Ahlberg.

The building is constructed of reinforced concrete. Since both the concrete and the binder in the form of cement have a large environmental impact, it was important from a sustainability perspective (lifecycle assessment, LCA) in this project to ensure that already used resources regarding building materials could be preserved. An important goal was also to preserve the raw character of the moulded concrete walls and that this character also could be adapted to the concrete structure of the new exterior entrance from Mariebergsgatan. Another challenge was to take advantage of the floor plan and change it from classrooms to apartments. New installations and pipework were hidden above the inner-roofs of the building and it is worth noting that the inner-roof of the large central stairwell is new, but carried out in the same material and by the same supplier as at the time of the construction in the 1960s. An important position was also that all surface layer work should be retouched rather than renovated. A major challenge was the problems with rusting reinforcement and the ability to repair about 400 injuries. The visible damage to the concrete elements of the façade was repaired. With water blasting, the concrete elements of the façade were released so that reinforcement and ballast became visible and could be restored. The restoration of the concrete surfaces of the façade was very demanding, where bricklayers, sculptors, conservators and antiquarians all worked to recreate a surface that on an overall level resembled the original. The exterior today preserves large parts of the original concrete and on those parts it is restored, the surface does not look new, this in accordance with the architect's intentions.

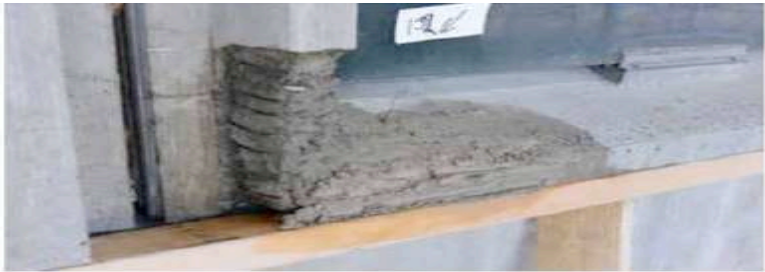
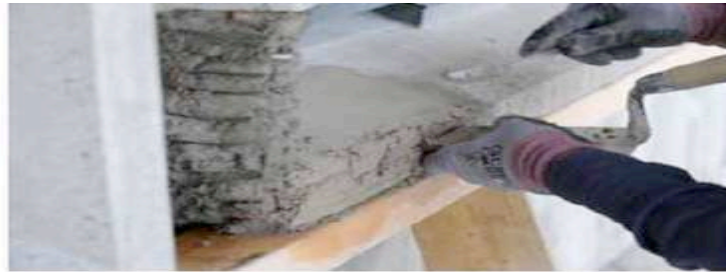
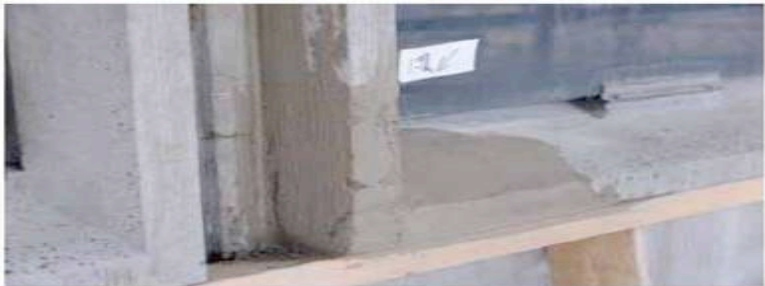
Tre bilder från lagningstillfället. De djupa lagningarna byggdes upp med betonglagningsbruk i flera påslag, varefter detaljustering av ytorna tog vid. Vid vissa lagningar infogades ny sjösten i fraktioner och kulörer, som stämde med omgivande ytor. På detta vis skapades en tillfredställande estetisk överensstämmelse mot omgivande betong.

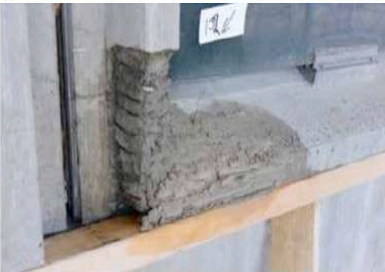
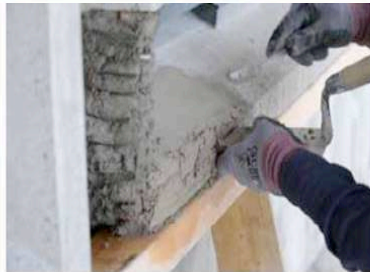
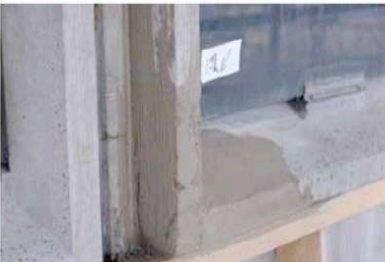
Conservation of concrete window. Photo: Sven Olof Ahlberg.

Tre bilder från lagningstillfället. De djupa lagningarna byggdes upp med betonglagningsbruk i flera påslag, varefter detaljustering av ytorna tog vid. Vid vissa lagningar infogades ny sjösten i fraktioner och kulörer, som stämde med omgivande ytor. På detta vis skapades en tillfredställande estetisk överensstämmelse mot omgivande betong.
