BALTIC REGION HERITAGE COMMITTEE

Good practices on built heritage conservation/restoration

Frische Grube 5, Wismar, medieval residential building.

Restoration of the half-timbered construction.

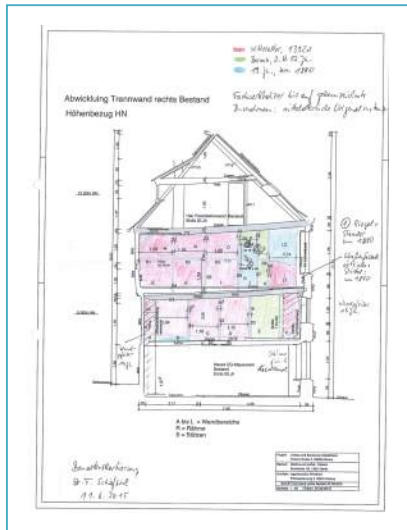
*Image No. 4, building age mapping 2015,
© Building research, Tilo Schöfbeck*

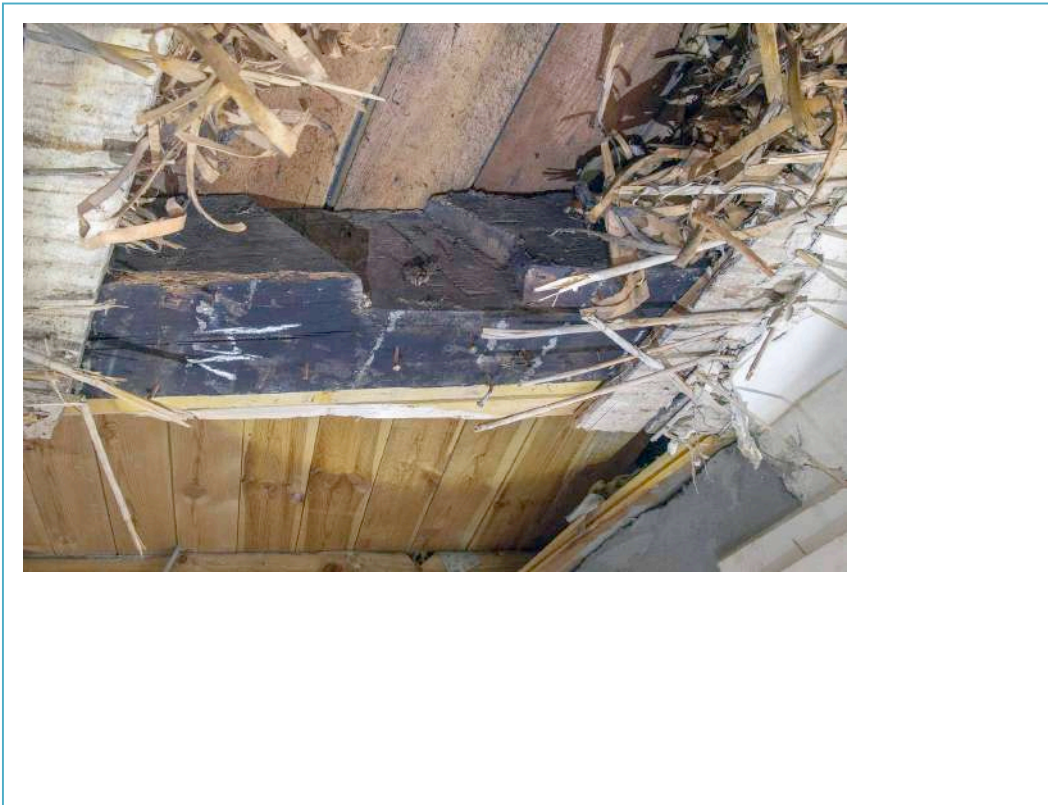
layer, above which there was a high post and beam structure for the hallway. For the lower sub-floor, again a smaller storey was put on top. This was braced to the roof beams, which are also in situ, with angle braces, all of which had hooklike halvings, with the typical conical tapering that existed only until about 1400. The dendrochronological examination indicated that it dated from 1393.

*Image No. 6, mortise of the angle brace in the upper floor,
© Building research, Tilo Schöfbeck*

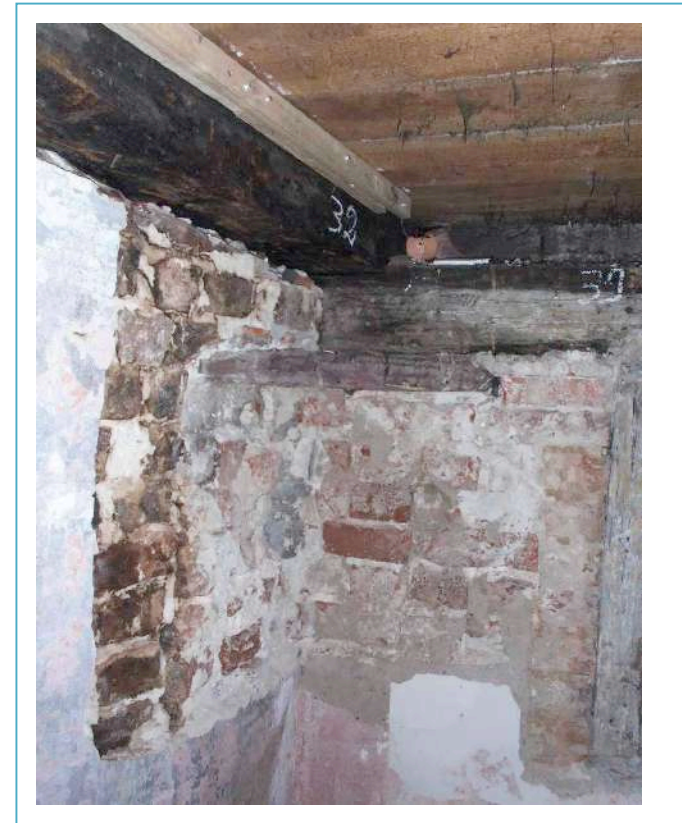
*Image No. 7, hearth on the upper floor,
© Building research, Tilo Schöfbeck*

As far as the structure's use is concerned, it is known that the hearth was located in the rear area of the house, in the north-west corner. When the supporting pillar there was worked back to gain space, presumably during the reconstruction in the middle of the 19th century, this surface remained without the typical blackening and sooting that otherwise characterise the fireplaces.

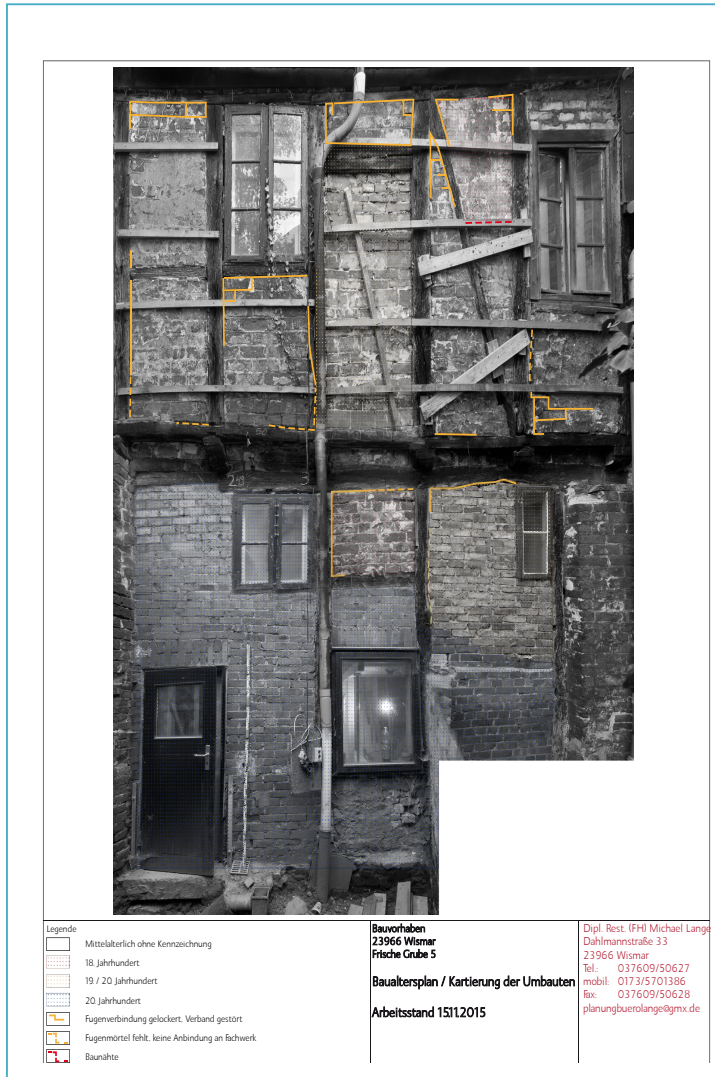
Image No. 12, building age plan/ mapping of the alterations, courtyard façade,
© Restoration examination, Lange, Wismar, 2015

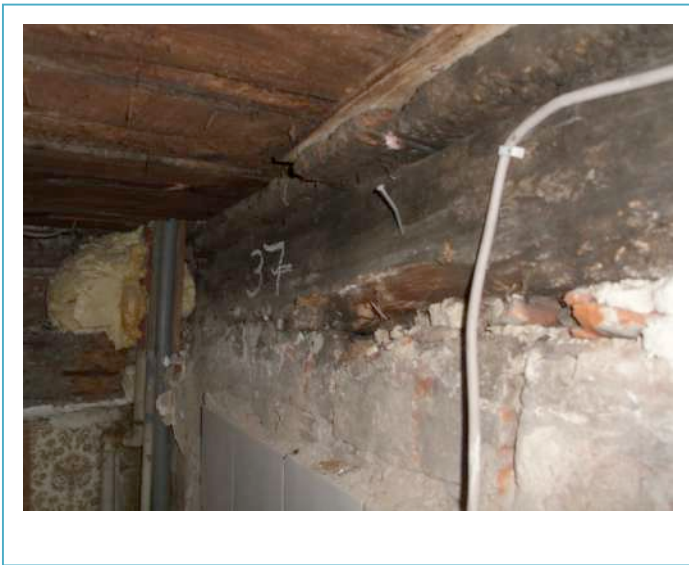
The building has two half-timbered gable walls facing the adjacent houses. From examining them in more detail, it is evident that this is part of a medieval terraced house; the half-timbered walls are therefore of high heritage value. Replacing them with solid construction would not have been acceptable in terms of monument preservation. One of the two walls was clad, the other left visible, as the neighbour had already erected a massive gable wall. The rear side of the building was given the first version of the brick infill, which has been verified by restoration work. Incidentally, the construction does not require wooden nails for the framework rails, as these were historically only wedged into the legs. The building was insulated using soft wood fibre mats within an internal wooden frame construction.

*Image No. 17, the eastern gable wall with remains of the historical flooring of the adjacent building,
© LAKD M-V, LD, Jan Schirmer*

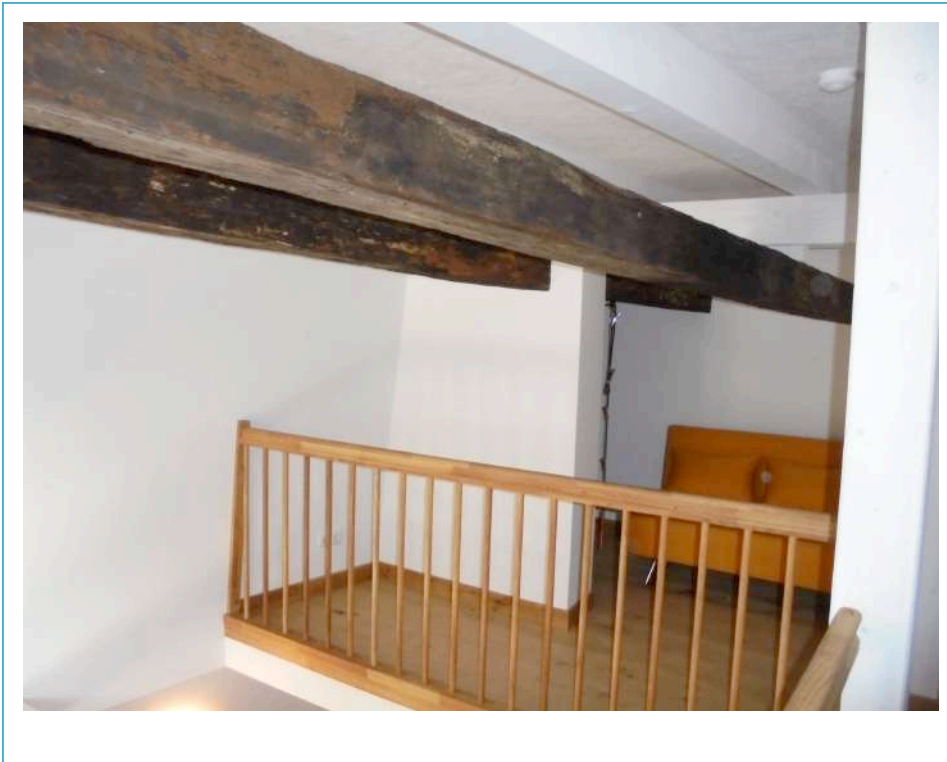
One problematic point in preserving historic interior structures was the room height. Inside the building, a mezzanine floor was retained as a low-height living area on the modern gallery within the former high hallway. The possibility of exemption from the specifications of the state building regulations was made use of. The medieval ceiling beams are an ornament rather than a “disturbing accessory”.

*Image No. 19, mezzanine above the new gallery,
© LAKD M-V, LD, Jan Schirmer*

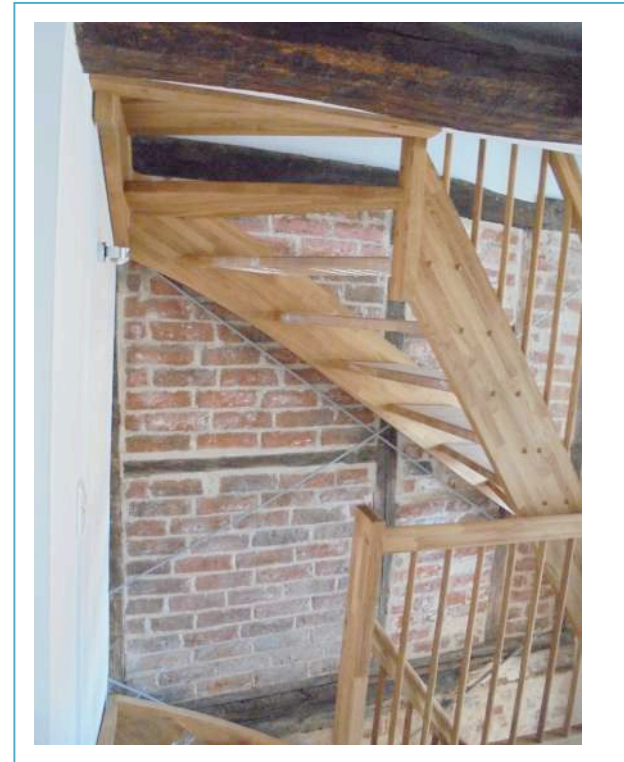
*Image No. 20, access to the newly created levels,
© LAKD M-V, LD, Jan Schirmer*
