Good practices on built heritage conservation/restoration

Dobele Castle Ruins.

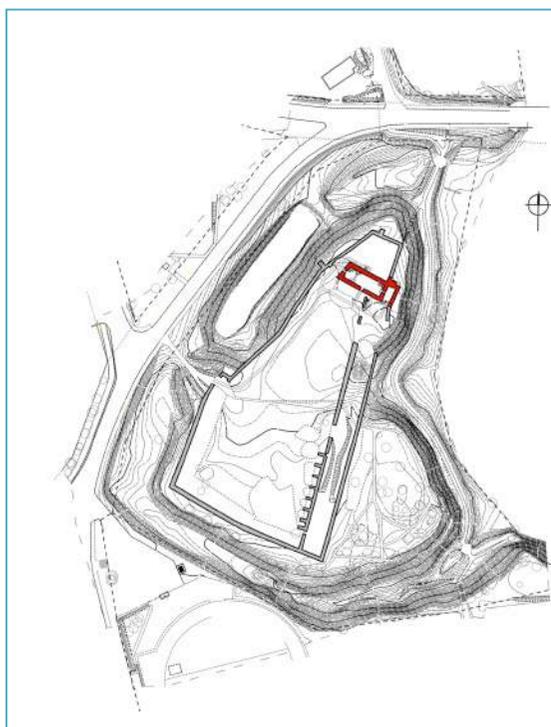
Image No. 1, plan of the Castle ruins, photo: SIA Konvents grafika Image No. 2, castle tower before restoration, photo: P. Blūms, 2016

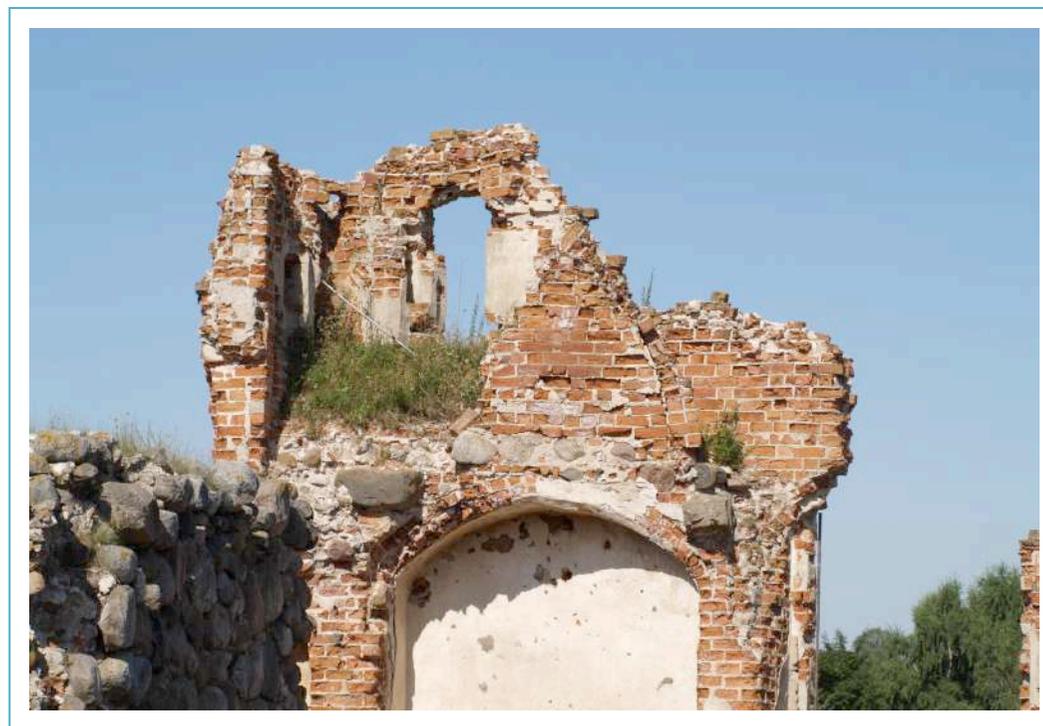
In the 1990s, a large part of the rubble-filled wall on the northern façade collapsed. The chapel's window frame arches on the northern façade had also lost about 60 – 80% of their stability.

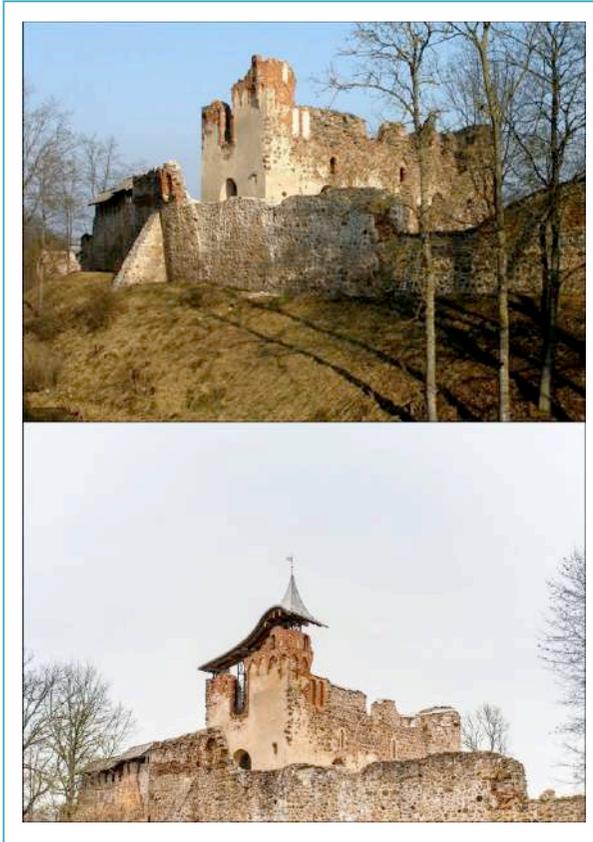
Image No. 3, Western view to the castle before and after intervention; photo: Kaspars Krauze "Krauzevision" 2020

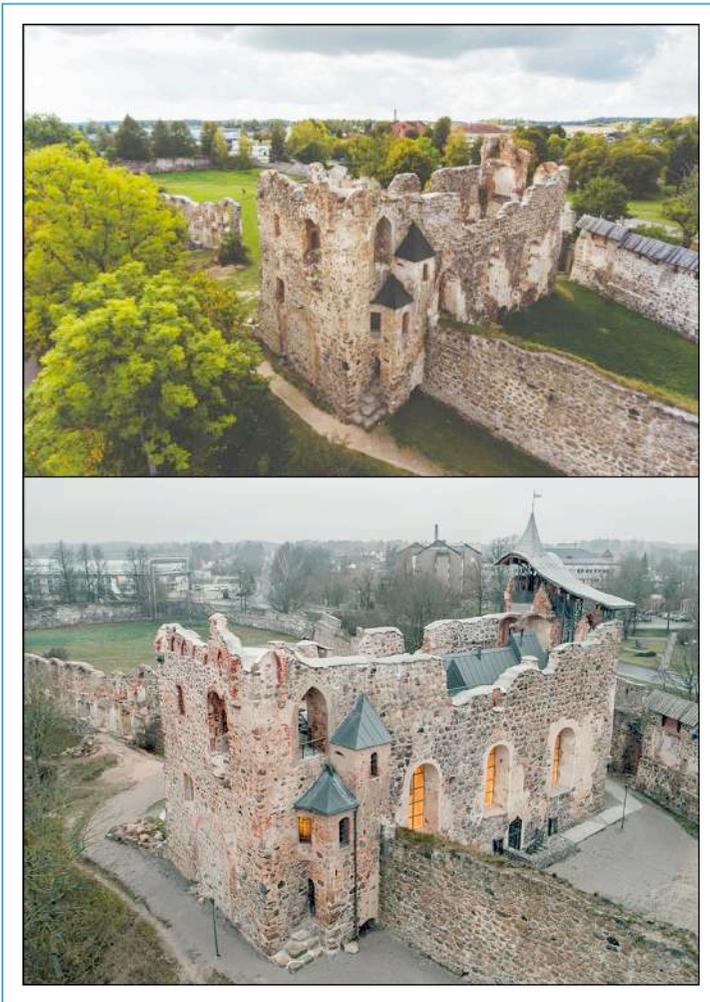
Image No. 4, Castle view before and after intervention, photo: Kaspars Krauze "Krauzevision" 2020

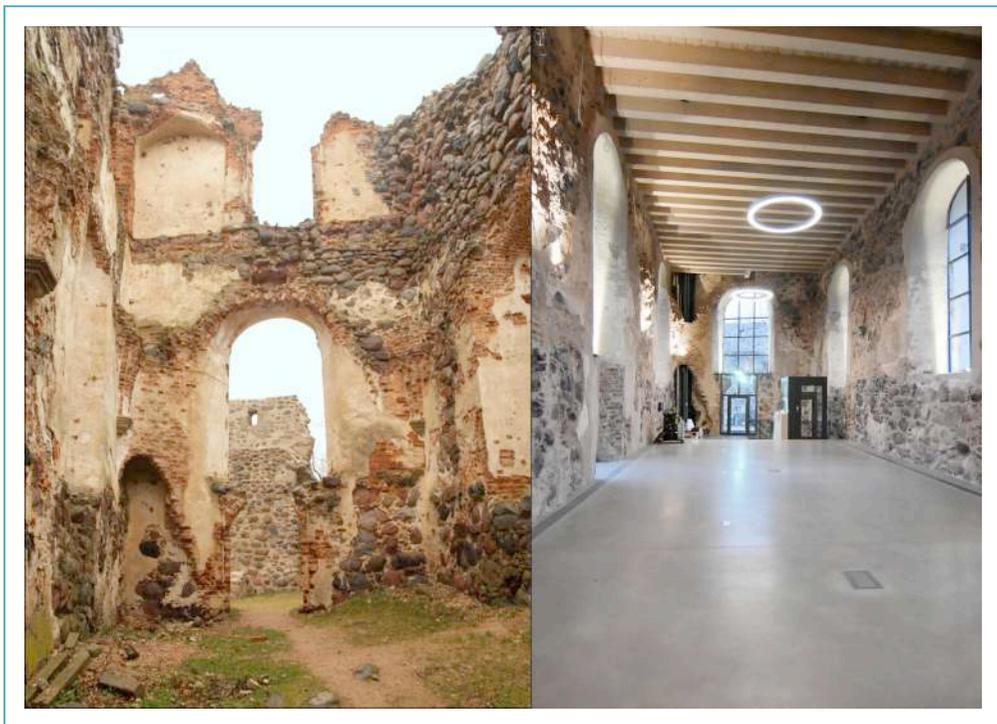
Image No. 5, interior view before and after intervention; photo: to the left - P. Blūms, 2016, to the right - Kaspars Krauze "Krauzevision", 2020

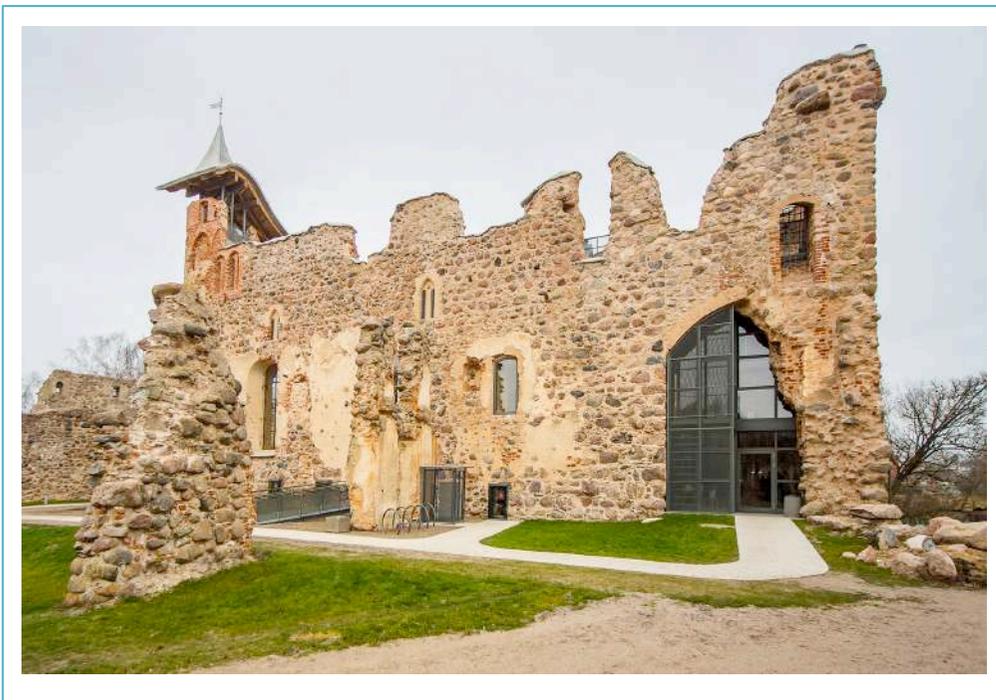
Image No. 6, Southern façade after intervention, photo: Kaspars Krauze "Krauzevision" 2020

The southern facade of the chapel has become an outstanding architectural background for large open-air concerts and events;

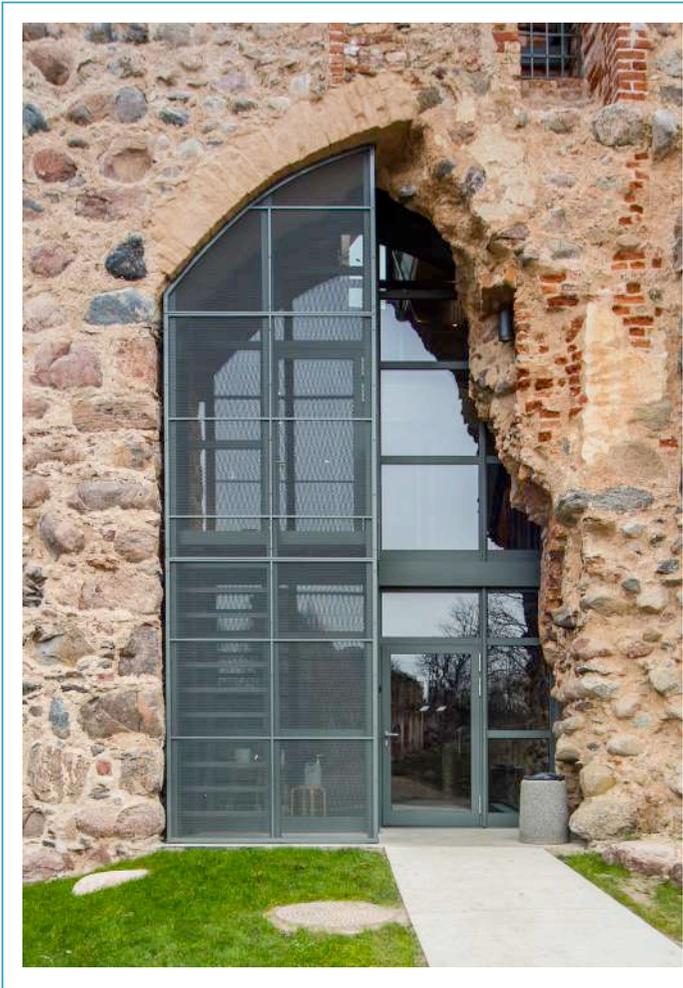
*Image No. 7, Façade element after intervention,
photo: Kaspars Krauze "Krauzevision" 2020*

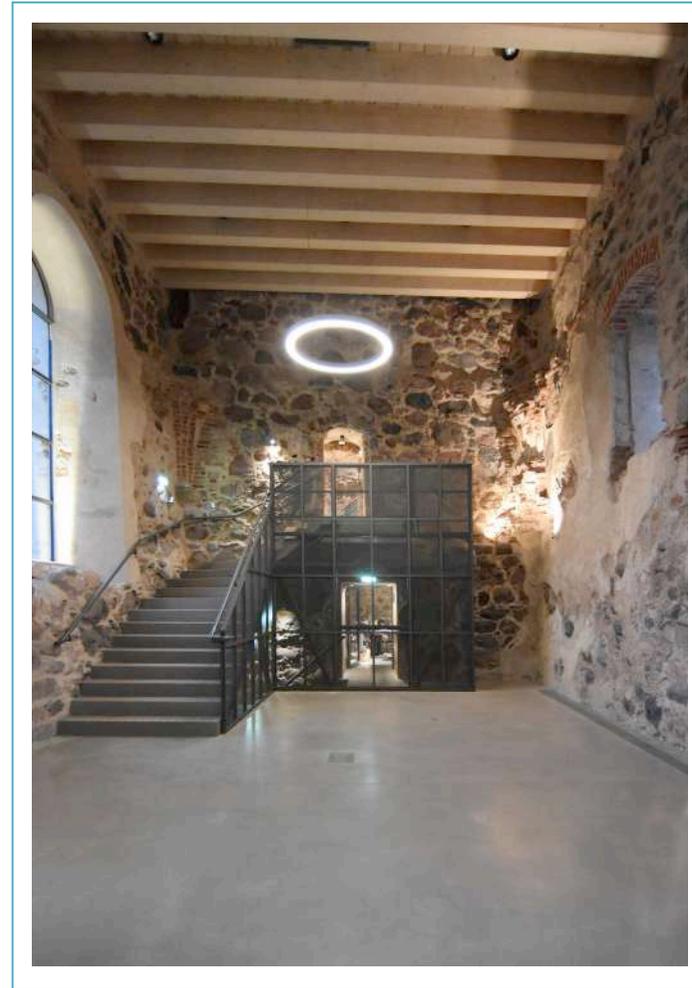
*Image No. 8, Interior elements after intervention,
photo: Kaspars Krauze "Krauzevision" 2020*
